Integrated Aquatic Vegetation

Management Plan 2009

Prepared For: Washington Department of Ecology

Moses Lake Irrigation & Rehabilitation District

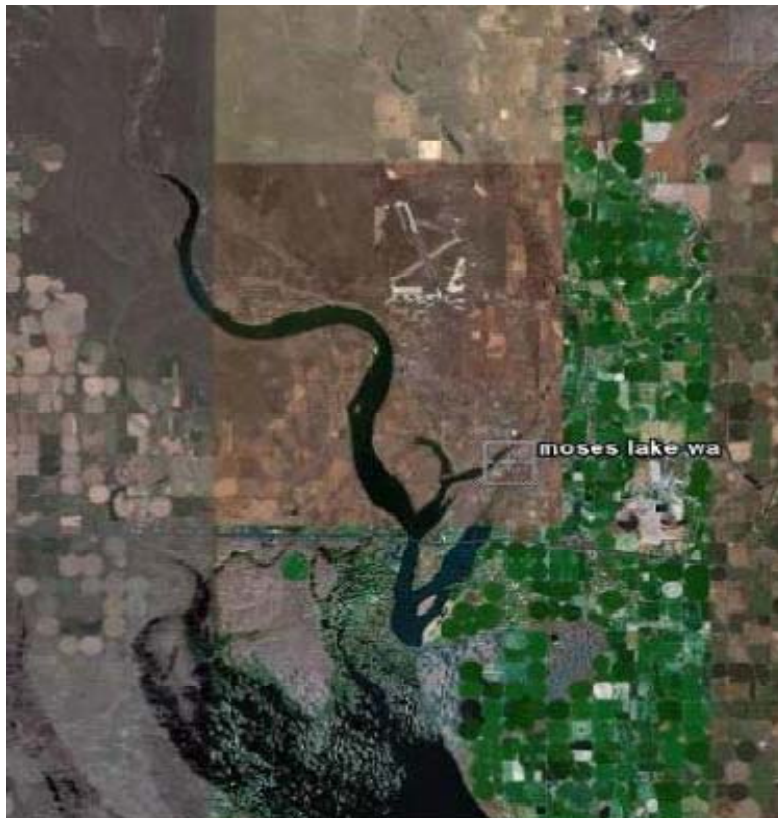
Fig 1. Aerial View of Moses Lake Waterbody.

Moses Lake is a 6,800 acre (surface area) water body with approximately 120 miles of shoreline, and is located in Grant County, Washington. At a water surface elevation of 1047 feet, the depth ranges from 2 to 35 feet deep. Moses Lake’s water shed is inclusive of portions of Lincoln, Adams, Grant, and Spokane Counties and receives perennial flows from Crab Creek and Rocky Ford Creek. Rocky Ford Creek contributes substantial flow but is a spring-fed stream with a very small surface drainage area. The Crab Creek drainage is approximately 2,200 square miles as measured upstream of the U.S. Bureau of Reclamation (USBR) gage located at Road 7 NE (3-miles upstream of Moses Lake). Rocky Coulee Wasteway drains to Crab Creek approximately 1.5-miles below the USBR gage on Crab Creek.

The two major sources of inflow to Moses Lake are Crab Creek, which flows into the northern tip of Parker Horn, and Rocky Ford Creek, which flows into the north end of the lake (Figure 1). Overall, Crab Creek where it enters Moses Lake exhibits a highly unusual flow regime that is sustained by groundwater, affected by flood episodes fed by snowmelt in the watershed, and by Bureau of Reclamation feed route releases through Rocky Coulee Wasteway just above Moses Lake. Most of the annual discharge volume of Crab Creek is contributed by Rocky Coulee Wasteway during several months of the spring and summer. The wasteway enters Crab Creek approximately one and one-half miles above Moses Lake and contributes approximately 85% of the total inflow to the lake from all sources. The Columbia Basin irrigation project's East Low Canal is the source of water for Rocky Coulee Wasteway except during infrequent winter storms. Rocky Ford Creek and the mainstem of Crab Creek (Gloyd Seeps springs) contribute approximately 10% and 5% respectively of the total flow into Moses Lake (WDOE 2002).

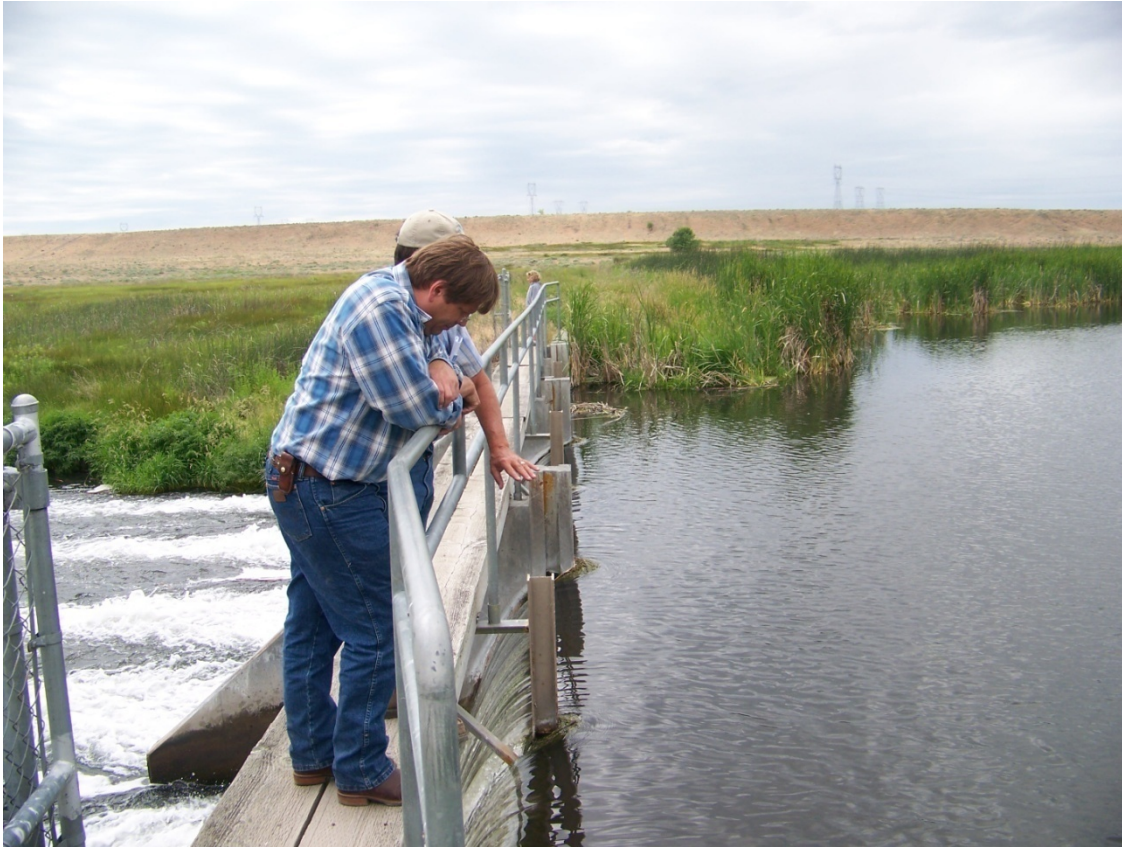
As previously mentioned the northern or main arm of the Moses Lake waterbody is fed by a small spring fed tributary known as Rocky Ford Creek. A small dam was constructed in 1987 at the lower end of Rock Ford Creek as part of the Moses Lake Clean Lake Project; the dam is Drumheller Dam. This dam was designed to prevent upstream migration of carp into the creek system as part of the program to enhance water quality within the Creek and Moses Lake waterbody. High phosphorous concentrations are associated with the Rocky Ford Creek system and were aggravated by carp activity within the Creek. This barrier provided a carp holding area and made efforts to rehabilitate the creek feasible. Carp were eroding the banks and uprooting vegetation within the creek. The remaining Carp in the Creek were eliminated by the Department of Fish and Wildlife and a trout fishery was established. In 1966 vandals removed the stop logs on the dam and compromised the dam's water quality control. The detention or holding area was eliminated and Carp were allowed to migrate upstream into Rocky Ford Creek. The State Department of Fisheries and Wildlife repaired the dam and rehabilitated Rocky Ford Creek during 1998.

Figure 12. Drumheller Dam at Rocky Ford Confluence

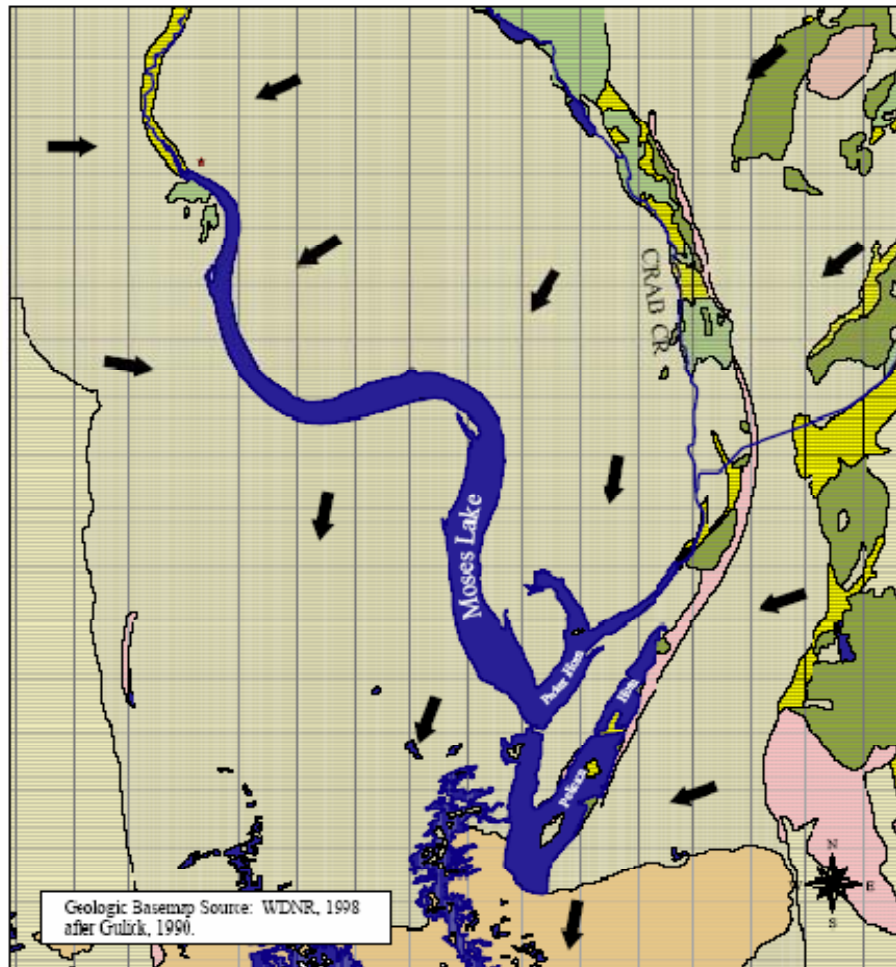
(Ephrata), and north (Soap Lake), and the northeast (Adrian). Recharge to the portion of Crab Creek between Adrian and Moses Lake is primarily from the east and northeast. Direct groundwater recharge to Moses Lake is from both east and west (Figure 13).

Figure 13. Groundwater flow direction in the Moses Lake basin (arrows). Tan areas around lake are Pleistocene gravel and sand flood deposits (from Pitz 2003).

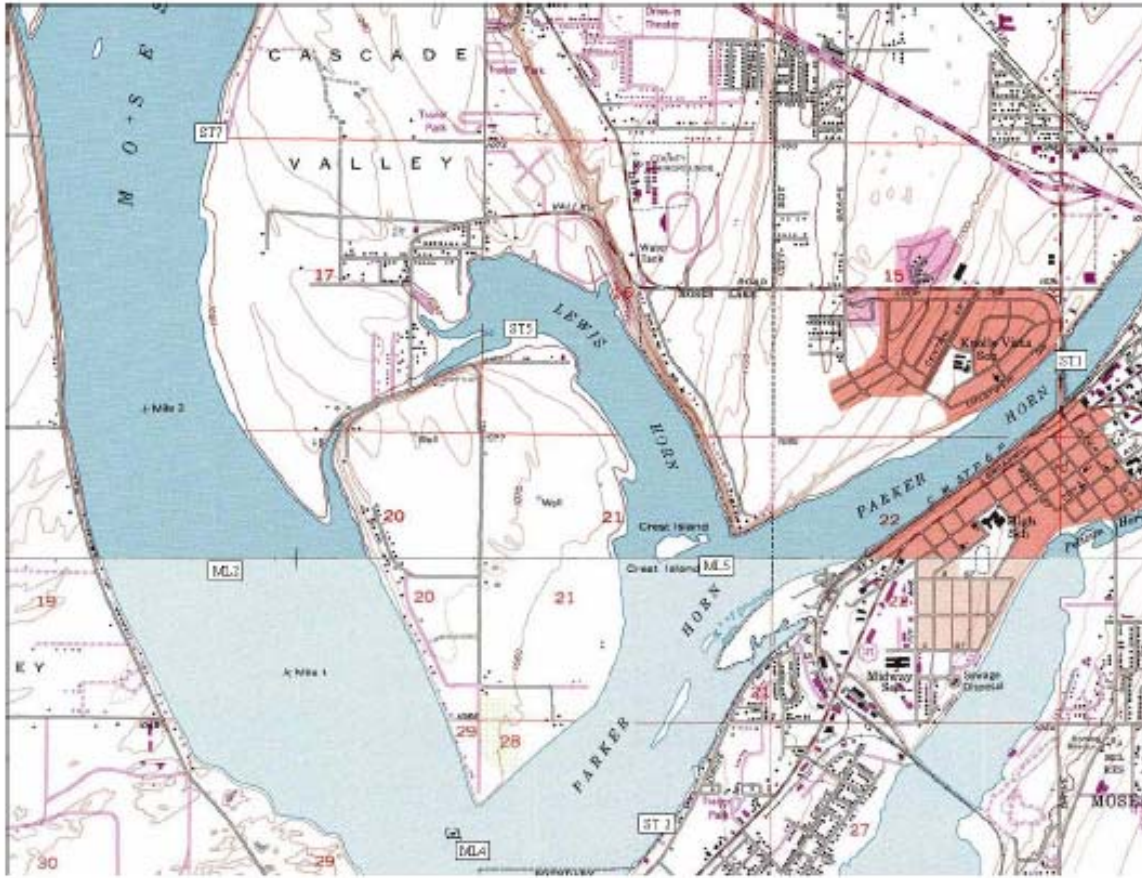
Figure 14. Cascade Valley Sampling Sites (Burgoon, 2008)

Lake Sampling sites are shown in figures 14 and 15. These sites are consistent with the 2001 TMDL lake assessment and other historic sampling records (MLIRD 2005).

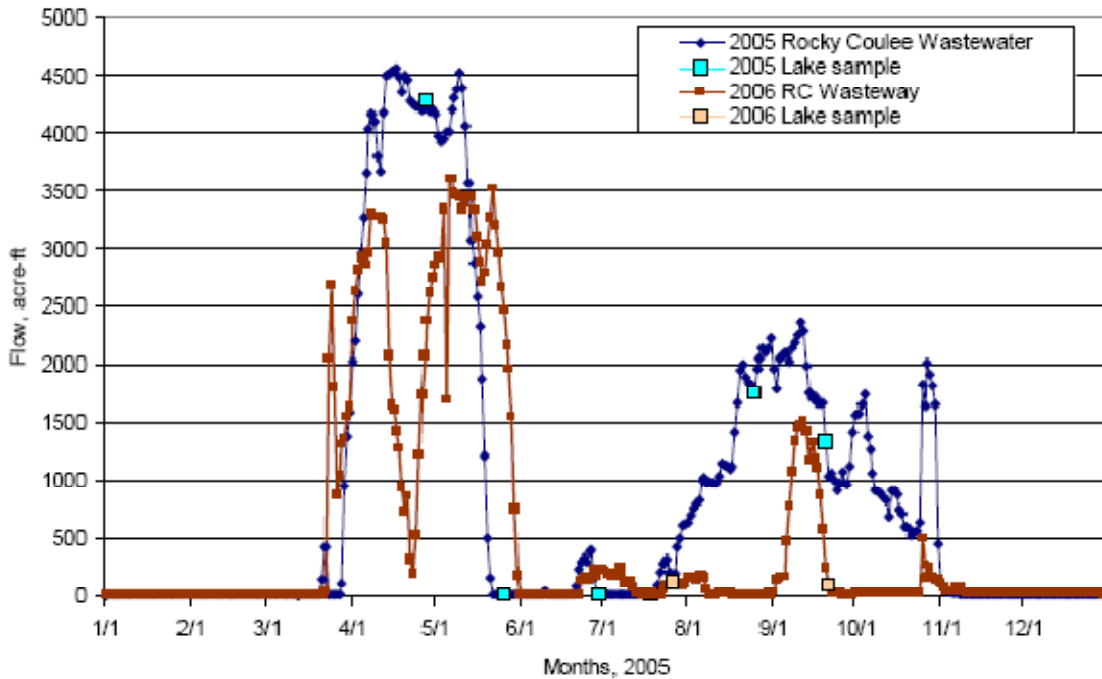
Total annual flow is not always a good indicator of lake quality during summer since significantly less dilution flow is available in the summer months. Figure 16 shows that in 2006 most of the dilution flow were added before July 1; of 194,000 acre-feet added in 2006 only 87% of the annual flow was released before July 1. Thus dilution flows in July, August, and September were very low in 2006. This was a major factor in high concentrations of TP and algae in the September lake samples.

Figure 16. Comparison of Dilution flows from Rocky Coulee Wasteway in 2005 and 2006

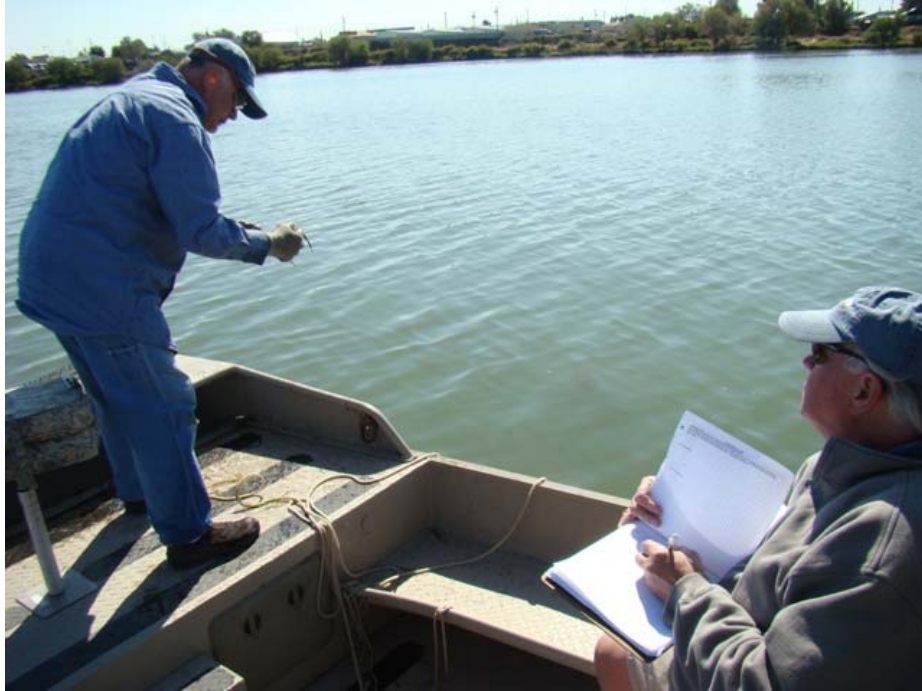
Figure 18. Lake Sediment Sampling (Klutz, 2008 survey)

Survey crew categorized the soil types and is shown by color on the legend, figure 19. The weed rack used made the soils easily determined as it was pulled along the lake bottom.

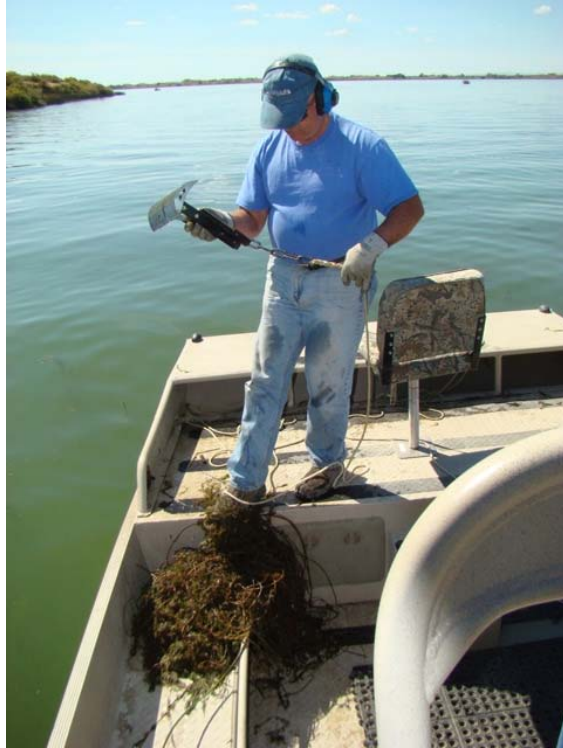
Figure 32. Plant Sampling (Kluttz, survey 2008)

The use of an Airboat allowed the survey crew to easily traverse shallow areas in addition to providing a good platform for identification.

Dave Kluttz (Lakeland Restoration Services) and crew visited every site shown on the subject map. With the use of a Garmin GPS, Rake; water testing equipment, and depth/GPS finder in an airboat. The crew established elevations, aquatic vegetation, water temp., dissolved oxygen levels, and Lake Bottom makeup.

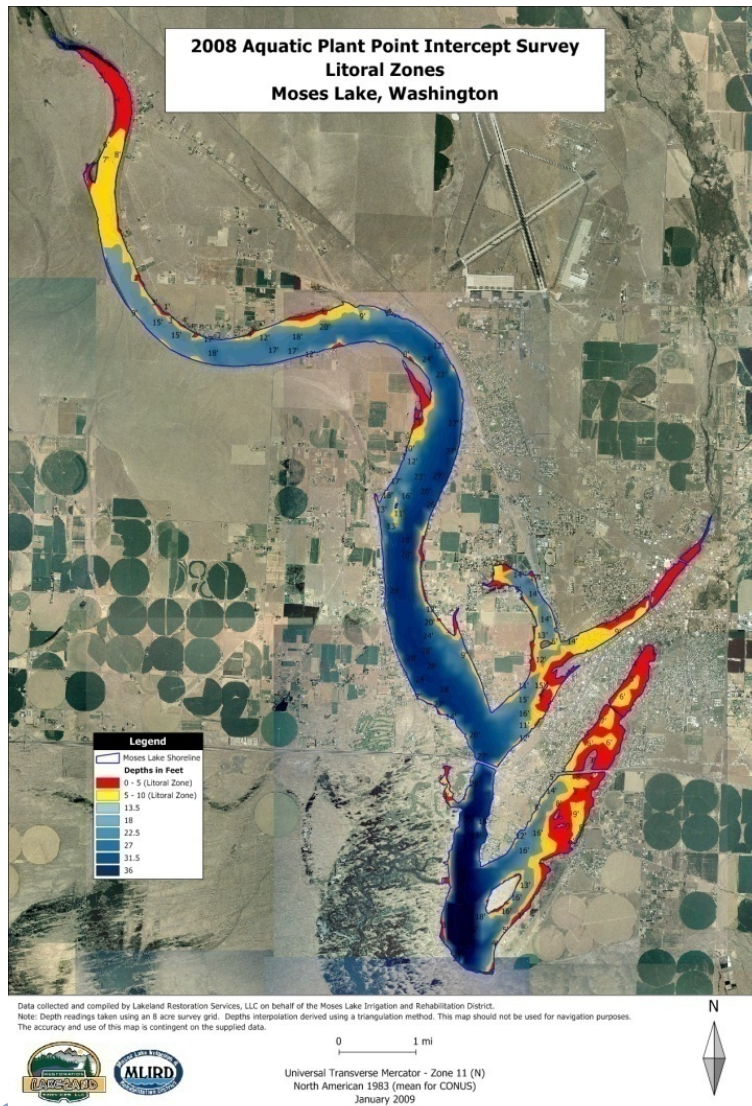
Figure 33. 2008 Aquatic Plant Point Intercept Survey Littoral Zones (Kluttz, 2008 survey)
Map Aquatic Plants

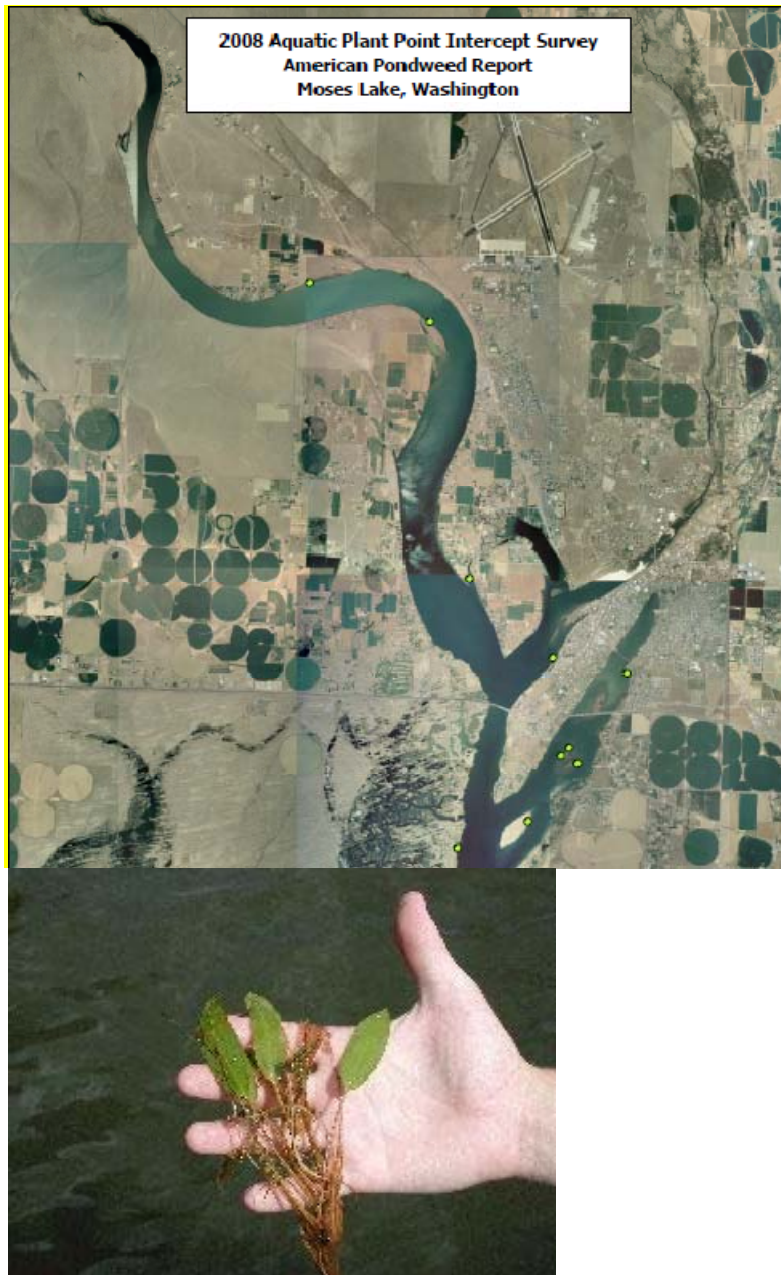
Figure 34. American Pondweed Report (Kluttz, 2008 survey)

American Pondweed found in few locations and primarily in the lower part of the waterbody in Pelican Horn

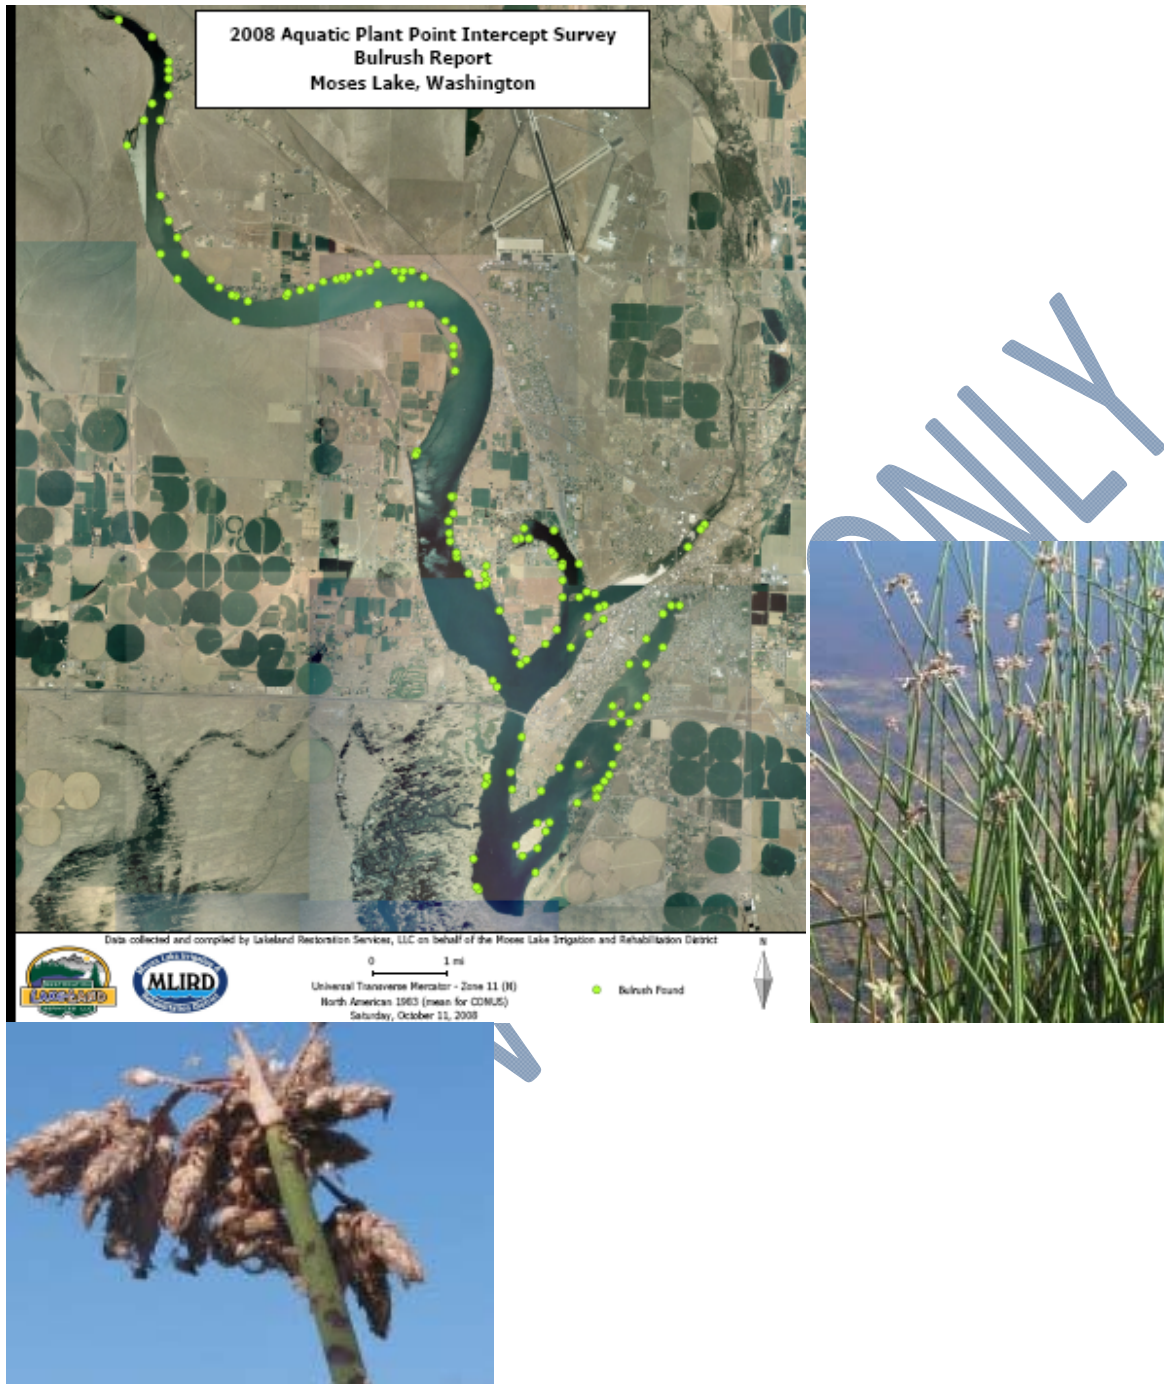
Figure 36. Bulrush Report (Kluttz, 2008 survey)

Bulrush was found in varying concentrations throughout most of the lake-some shoreline without evidence of Bulrush. Growth was along the shoreline.

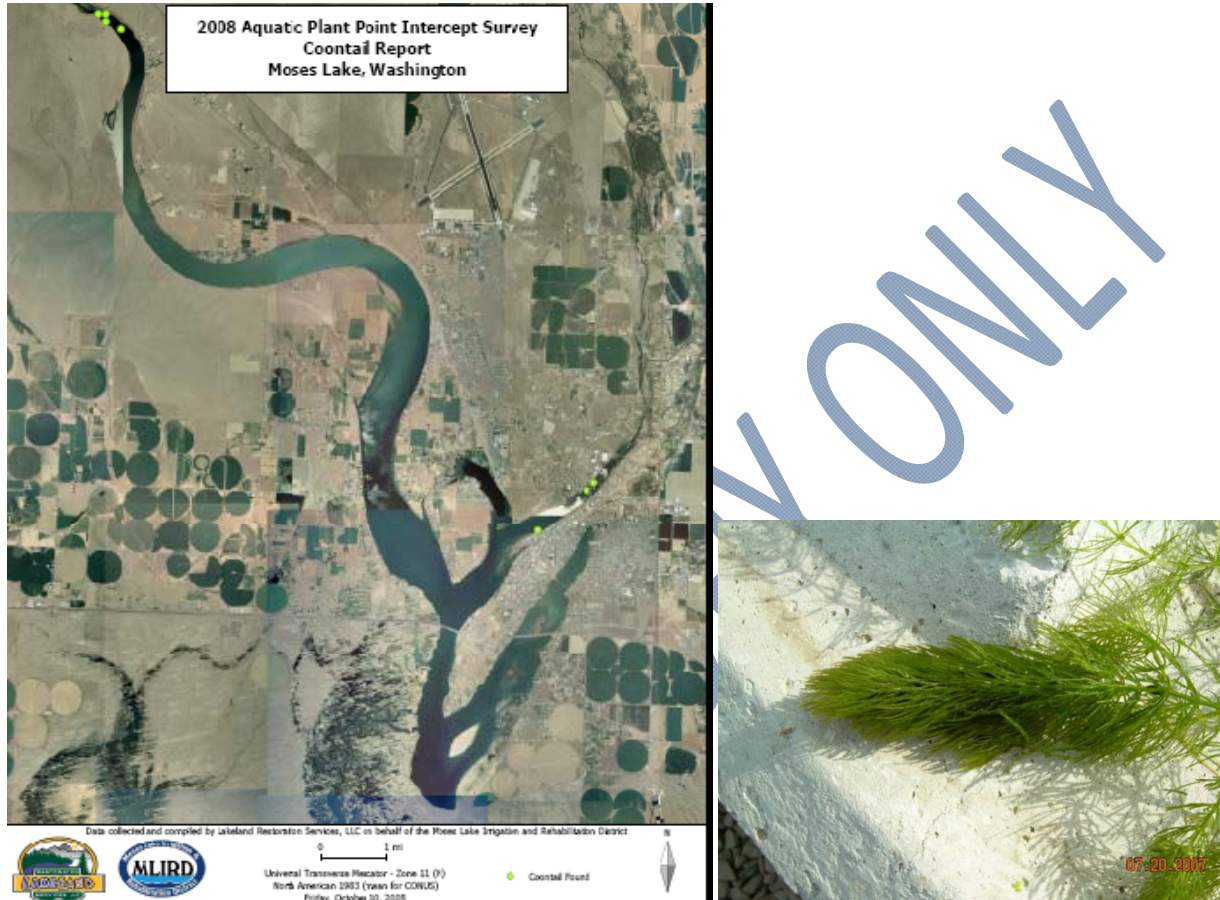
Figure 37. Coontail Report (Kluttz, 2008 survey)

Coontail was found in the upper reaches of the North end of the waterbody and Parker Horn. These areas are primarily the inlets to the lake. Coontail are growing in very shallow water depths, 0'-5'.

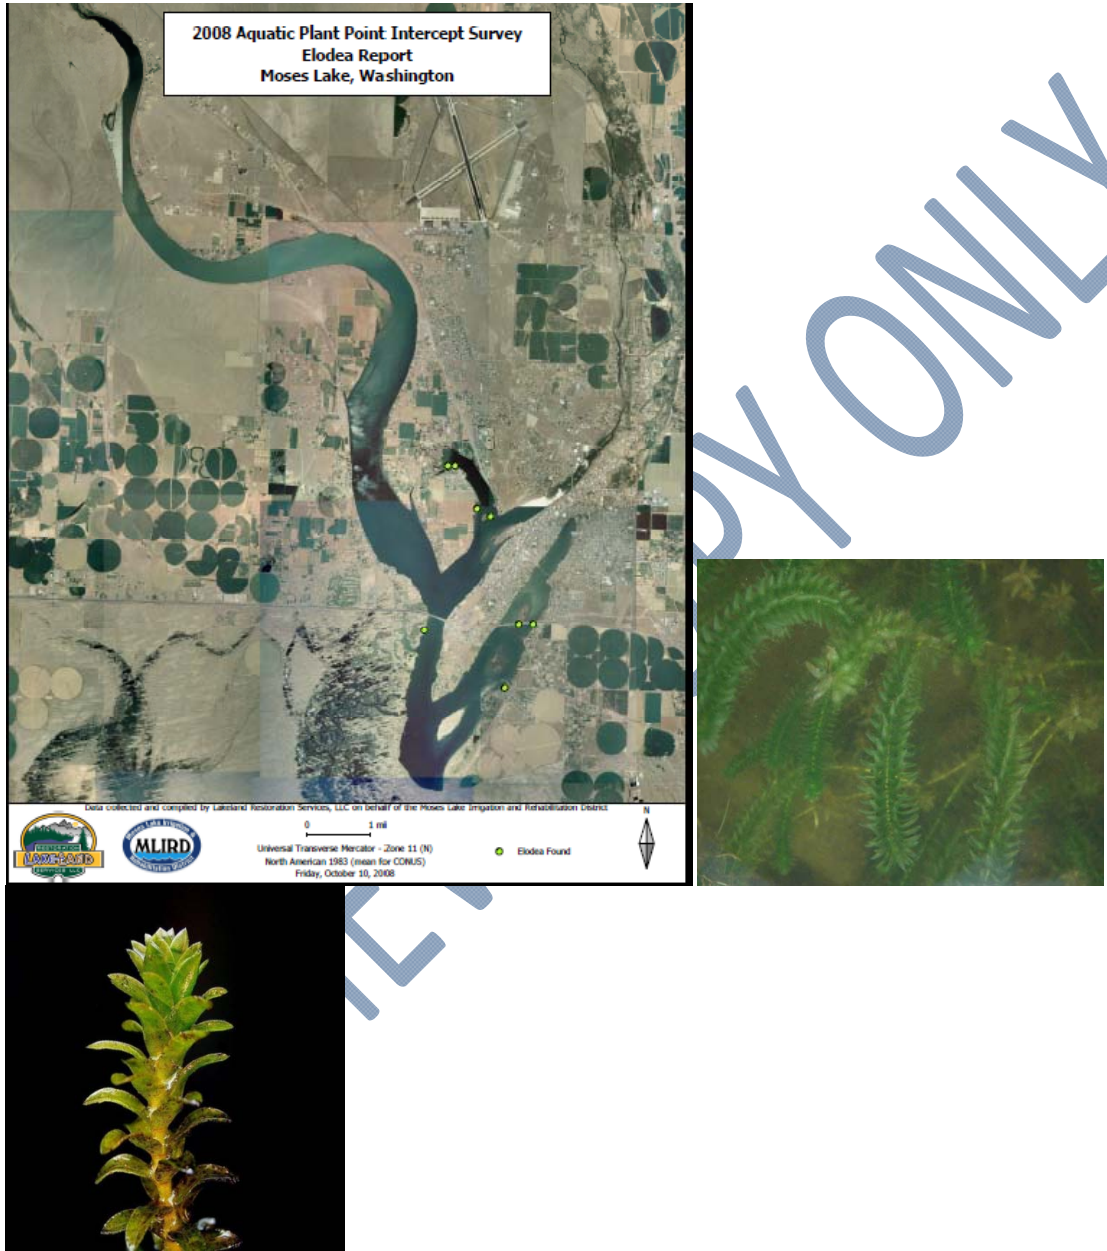
Figure 42. Elodea Report (Kluttz, 2008 survey)

Elodea was found in small concentrations in Lewis Horn and Pelican Horn with a trace amount on the edge of Pogo Island. The elodea was found in shallow water, 0'-5'. Figure 42.

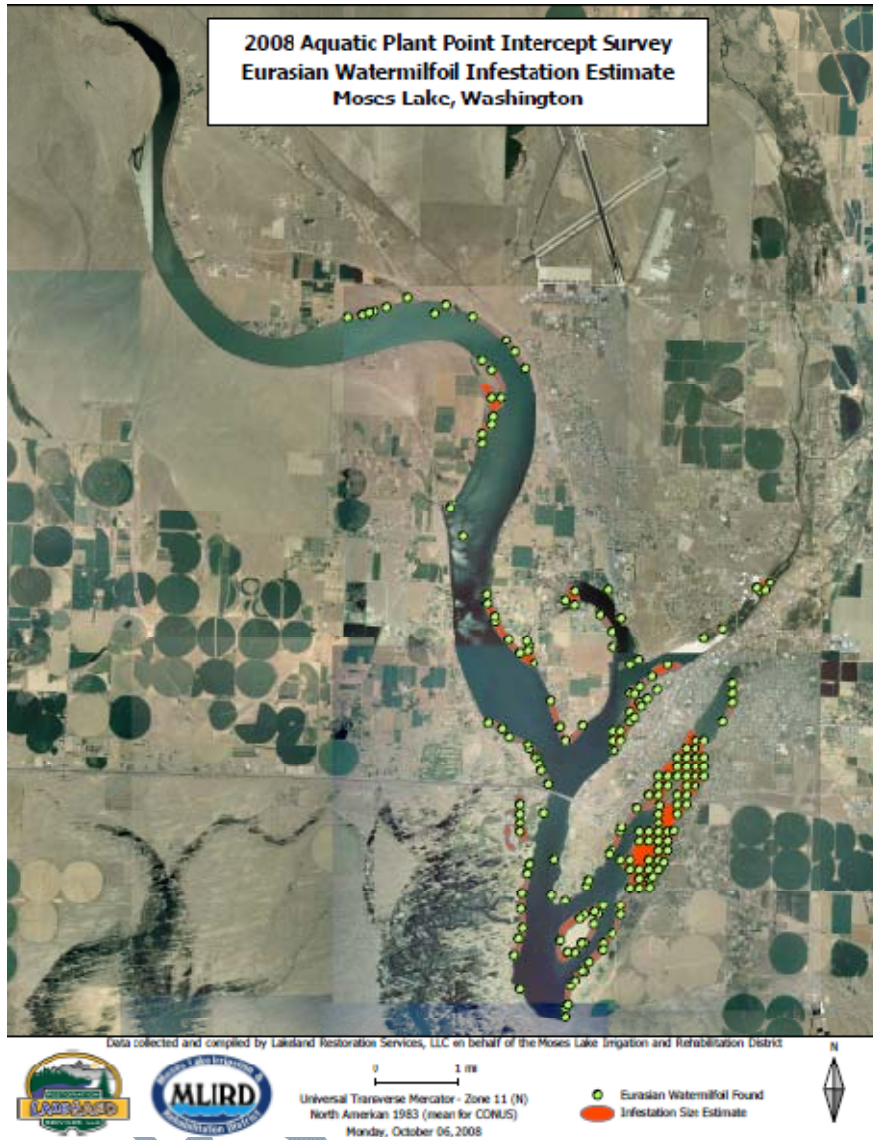
High concentrations of Watermilfoil were found in various locations on the waterbody; the highest concentration in Pelican Horn in 5'-10' water levels, figure 43.

Figure 43. Eurasian Watermilfoil Infestation Estimate in Moses Lake (Kluttz, 2008 survey)

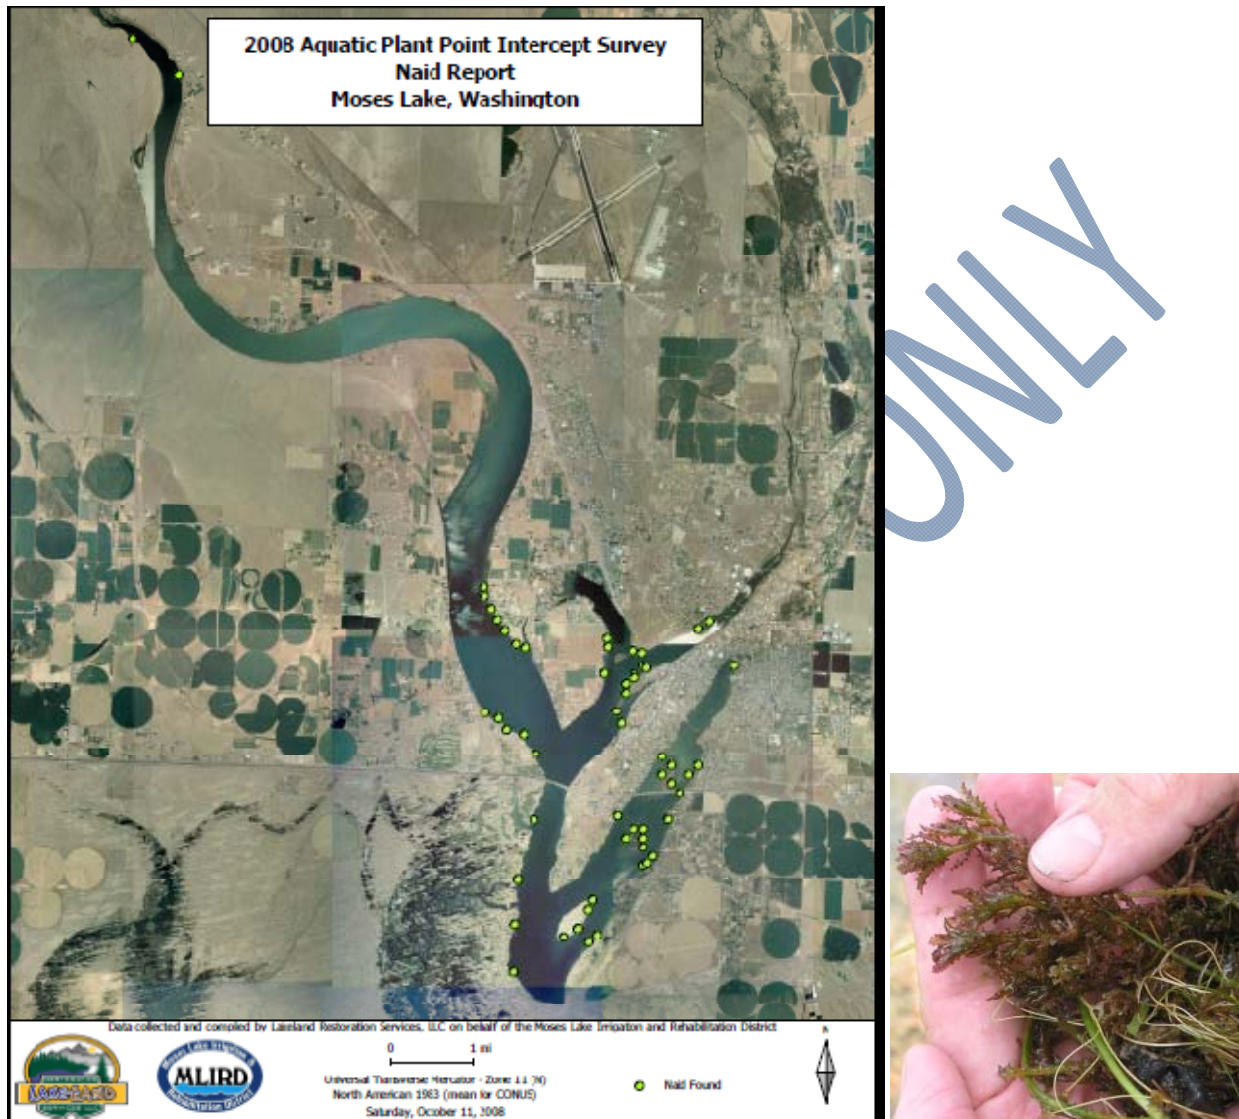
Figure 50. Naid (Kluttz, 2008 survey)

Naid is found primarily in the southern portion of the waterbody, concentrating in Parker Horn and Pelican Horn with plants found along the shoreline on the main waterbody, figure 50.

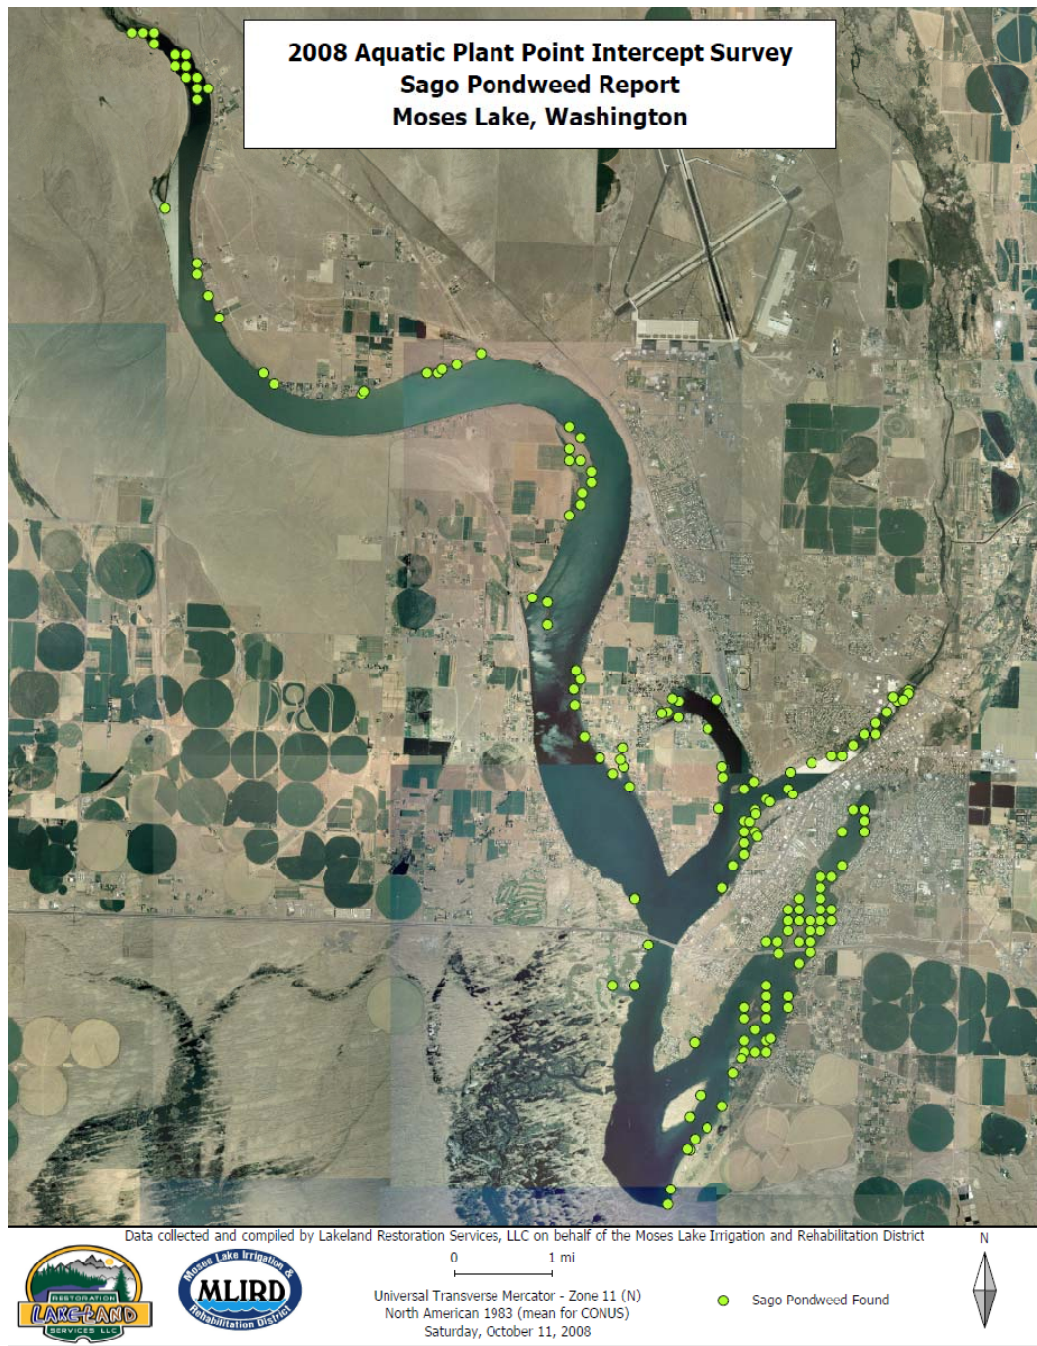
Figure 52. Sago Pondweed (Kluttz, 2008 survey)

Sago Pondweed, figure 52.

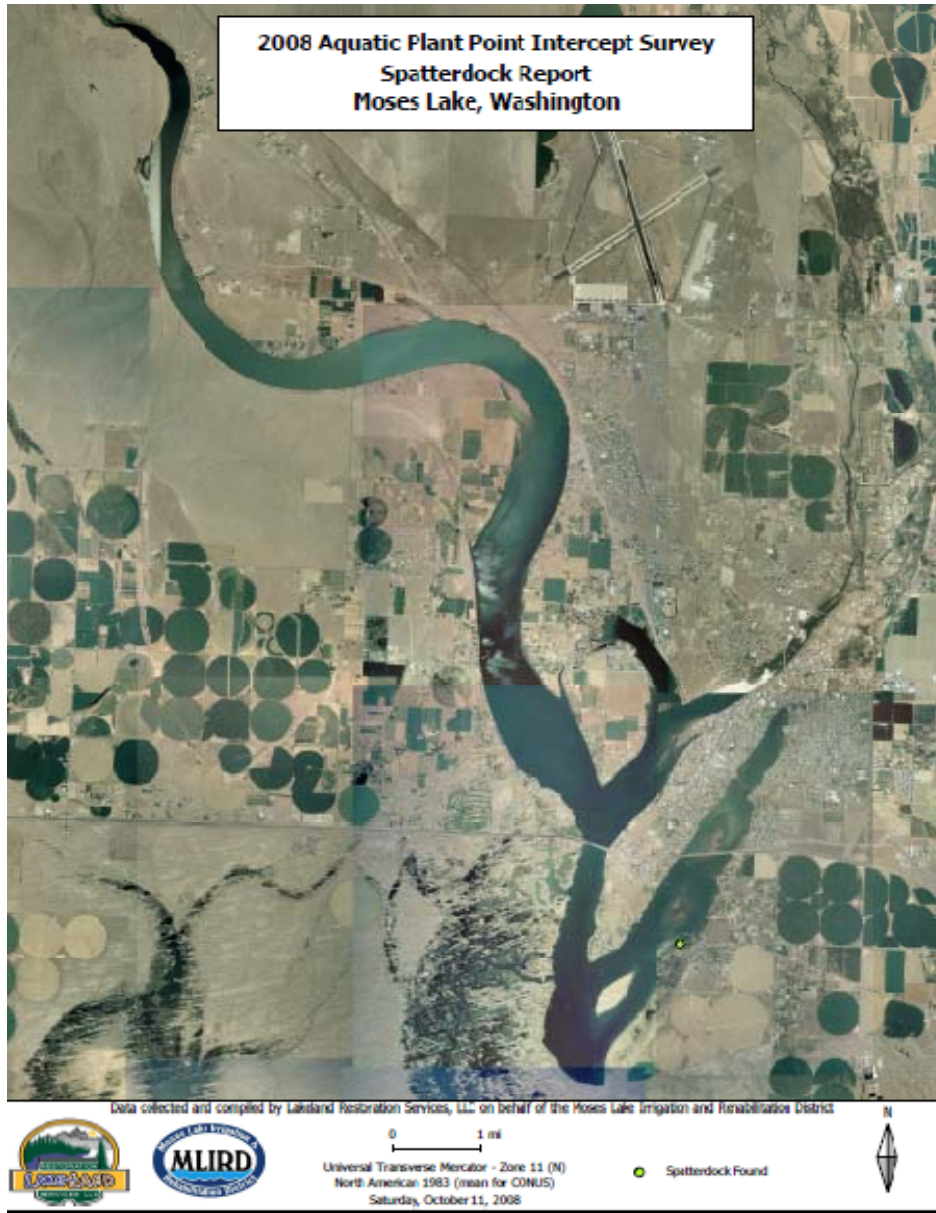
Figure 53. Spatterdock (Kluttz, 2008 survey)

Spatterdock –A single location was found in Pelican Horn and noted on figure 53.

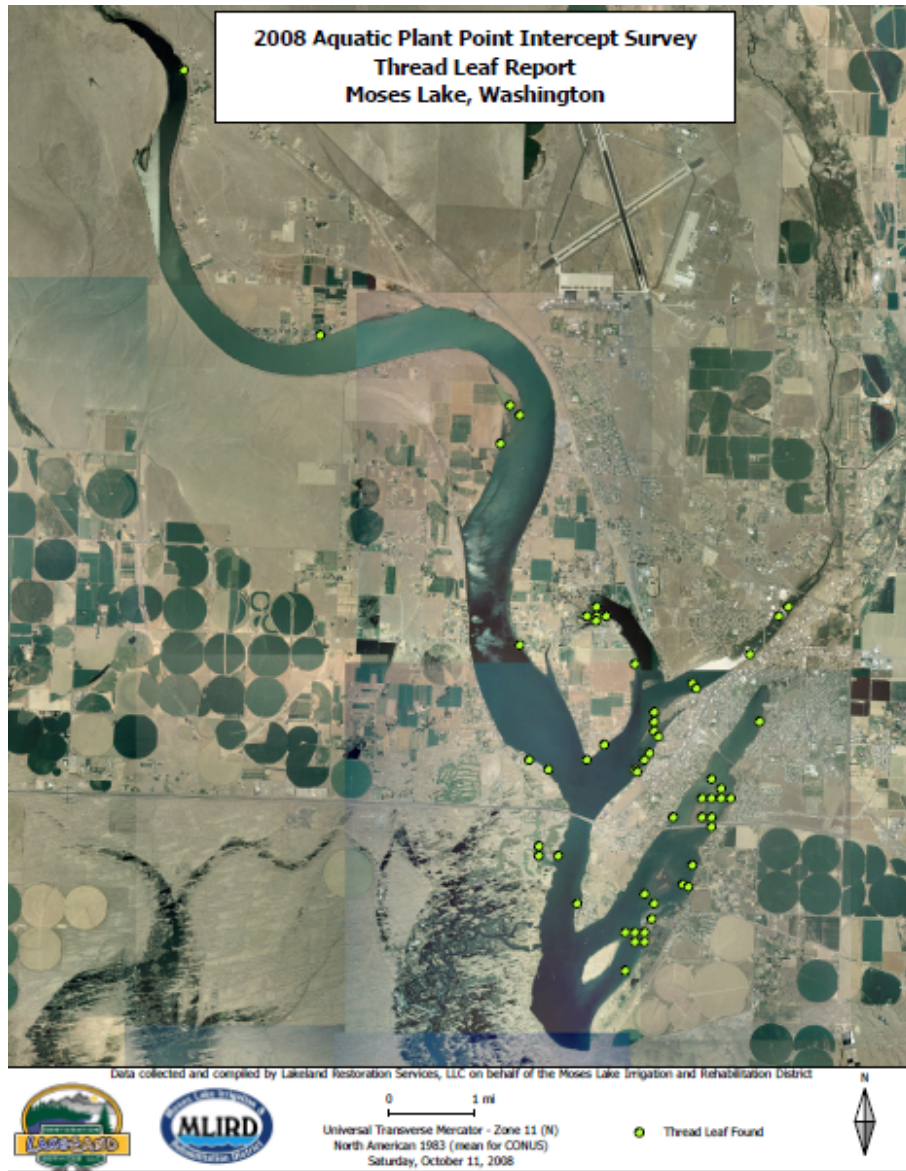
Figure 54. Thread Leaf (Kluttz, 2008 survey)

Thread Leaf was primarily found in Pelican Horn, Parker Horn, Lewis Horn and Spyglass Bay- also, found in small concentrations in sparse areas, figure 54.

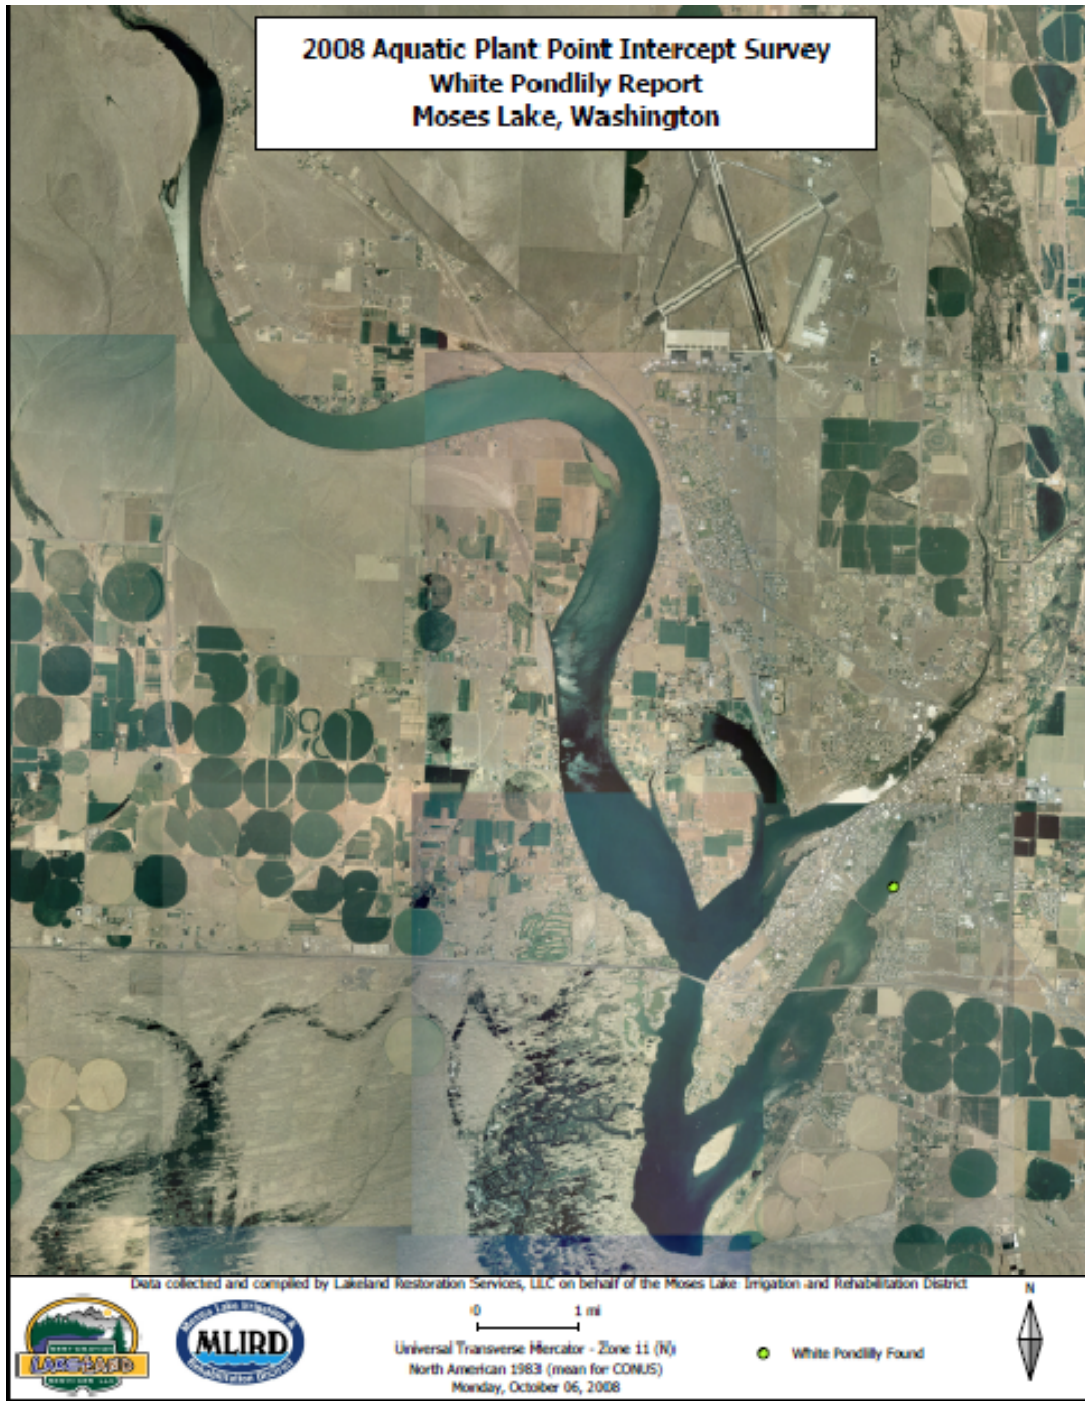
Figure 55. White Pond Lily (Kluttz 2008 survey)

White Pondlily was found at a single location on the Pelican Horn as noted on the map, figure 55.

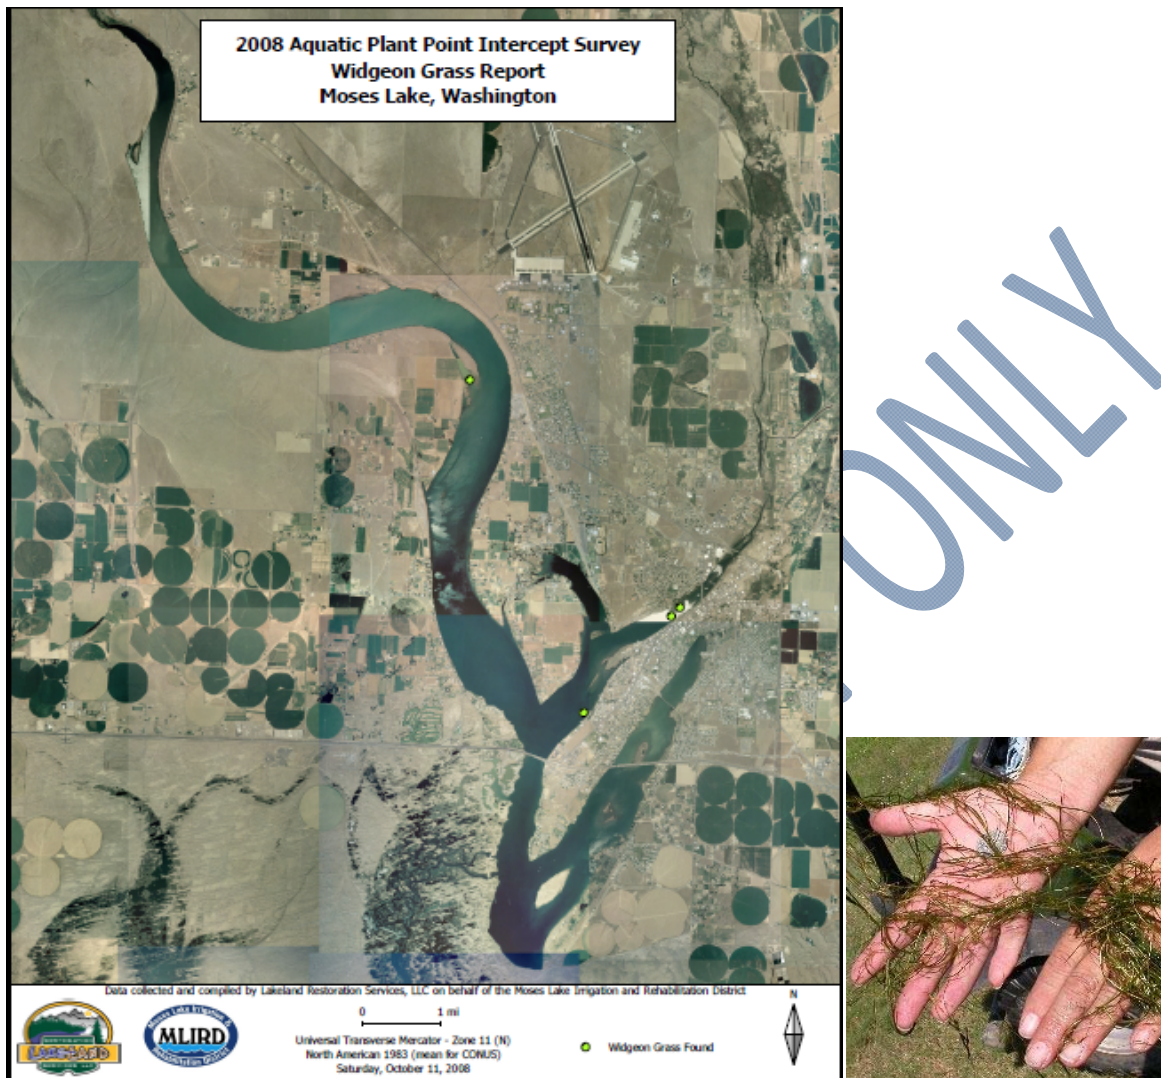
Figure 56. Widgeon Grass (Kluttz, 2008 survey)

Widgeon grass is sparse and was found at four sites as noted on the map, figure 56.
