Integrated Aquatic Vegetation

Management Plan 2009

Prepared For: Washington Department of Ecology

Moses Lake Irrigation & Rehabilitation District

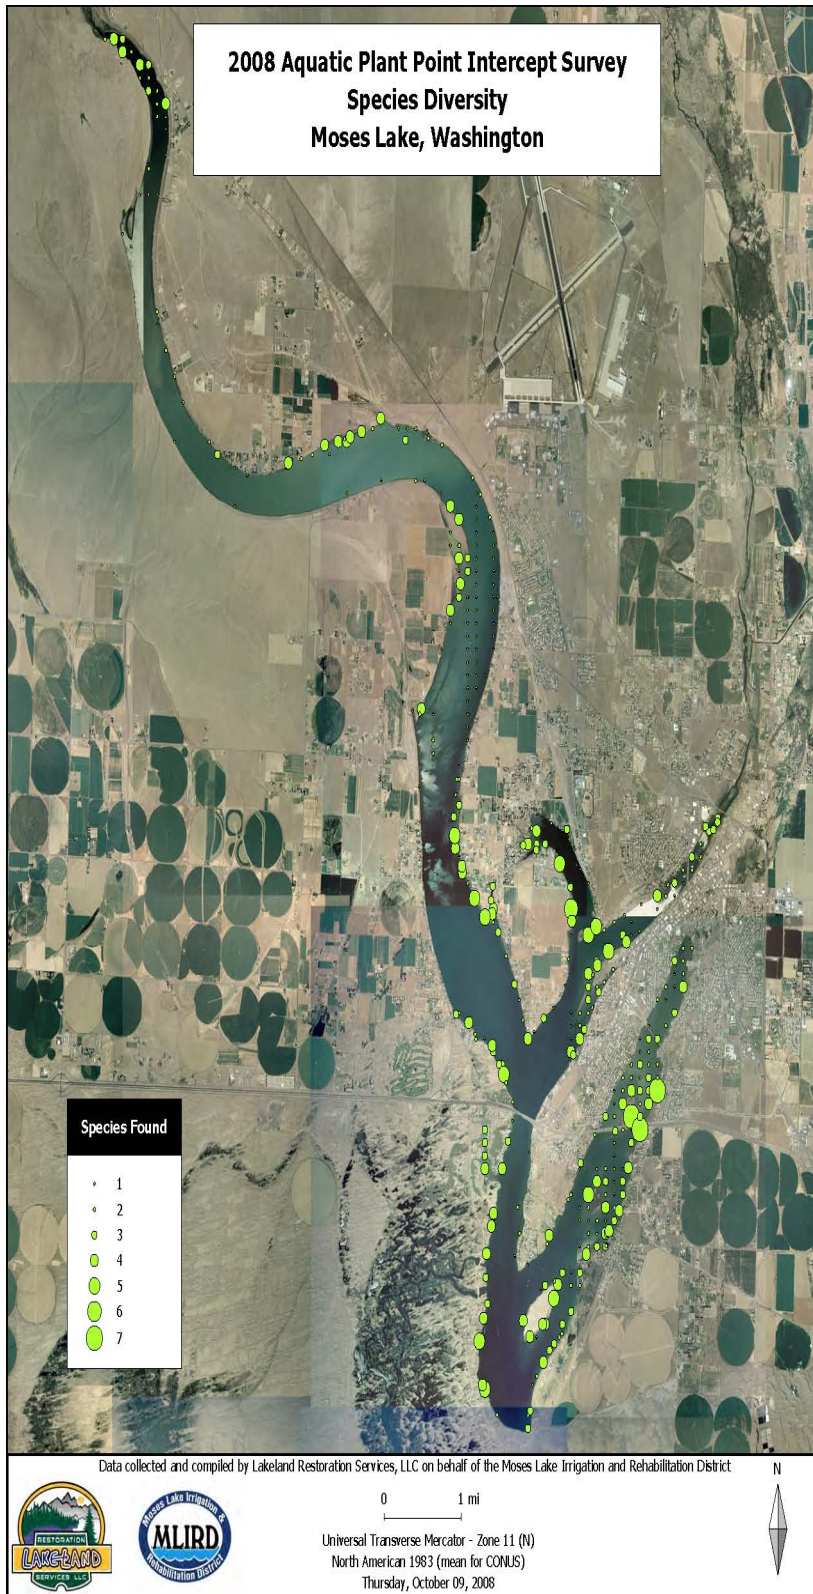
Figure 57. Species Diversity (Kluttz, 2008 survey)

Areas of high plant diversity are indicated on the map. It should be noted that the highest diversity of plant species are located in the Pelican Horn and in shallow water, 0'-10', figure 58.

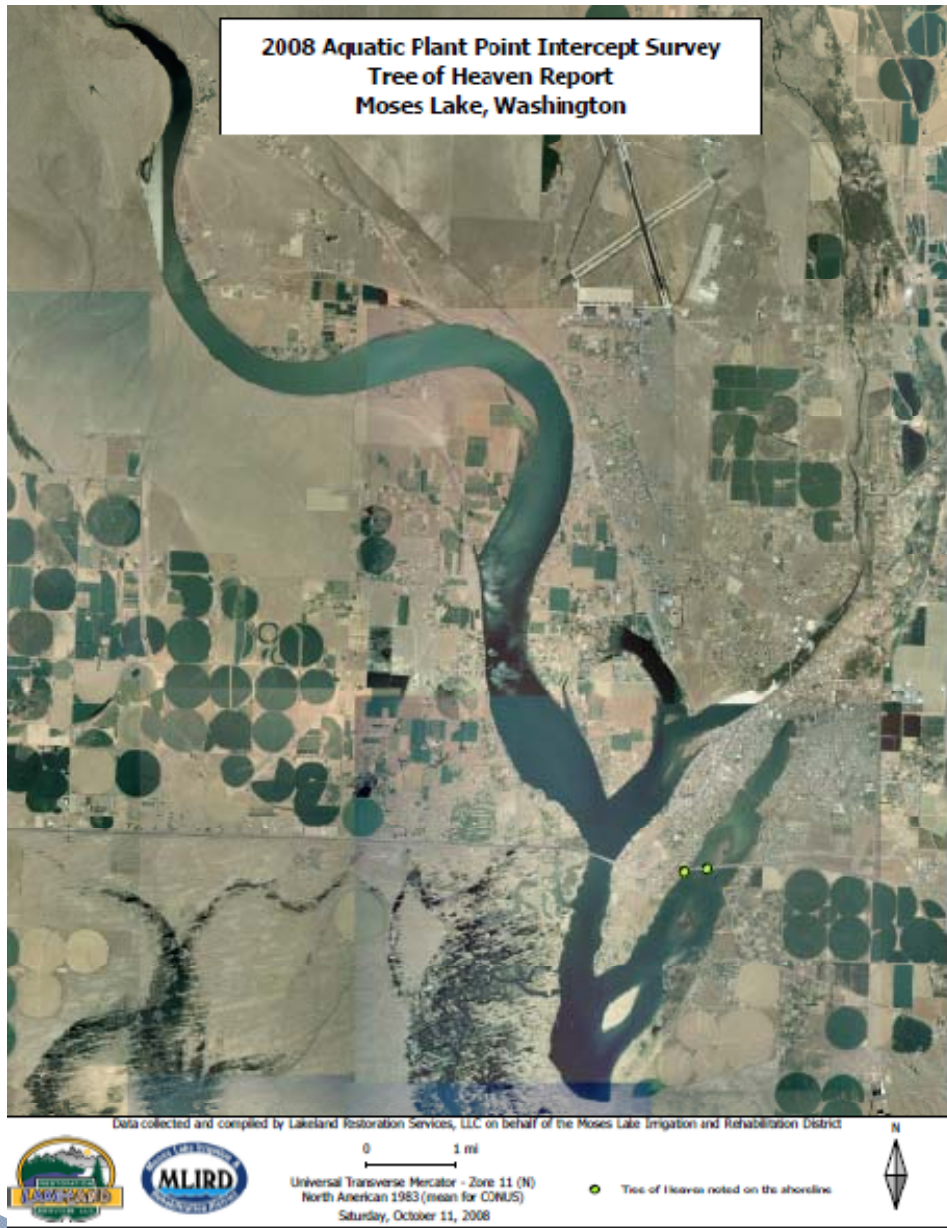
Figure 59. Tree of Heaven (Kluttz, 2008 survey)

Tree of Heaven was found at two locations in the Pelican Horn, figure 59.

The tree of heaven has been identified only in Pelican Horn, near the border of McCosh Park. See figure 59. Salt Cedar is on figure 60. Yellow Flag Iris is on figure 58. Phragmites is only found along the shoreline of Pelican Horn and is figure 63. Purple loosestrife is found on figure 61 and is located in inlets where minimal flow occurs. Russian Olive is found on figure 62 and infests many areas of the shoreline. It was introduced in the early years of Moses Lake by

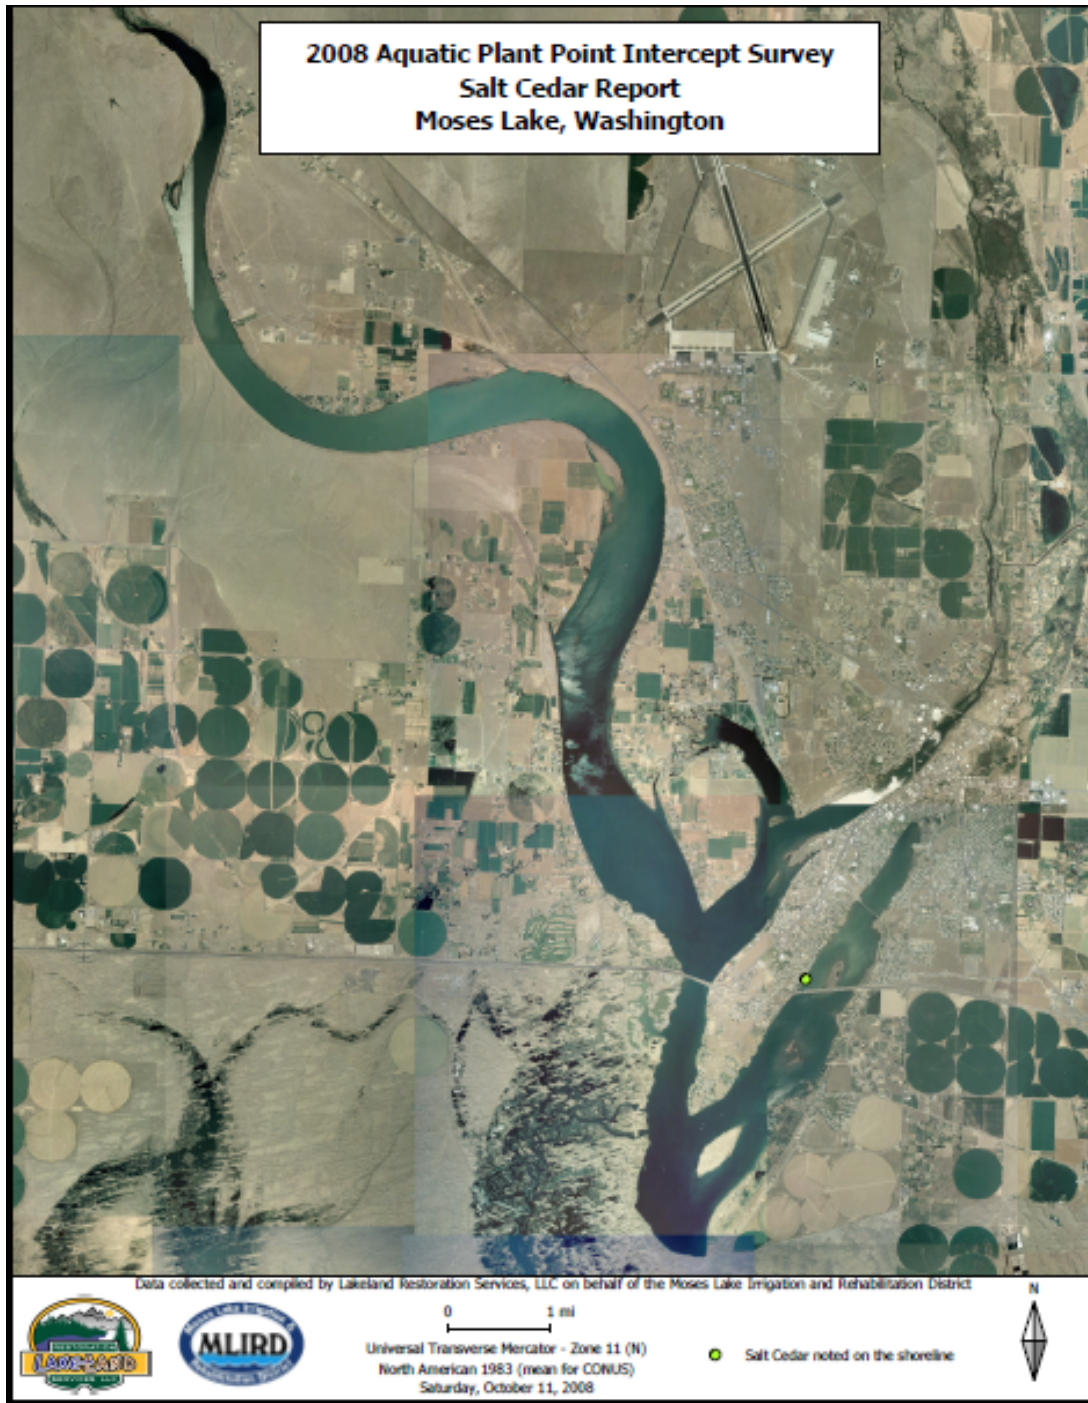
Figure 60. Salt Cedar (Kluttz, 2008 survey)

It is noted on the map that Salt Cedar was found in one location on the waterbody, figure 60.

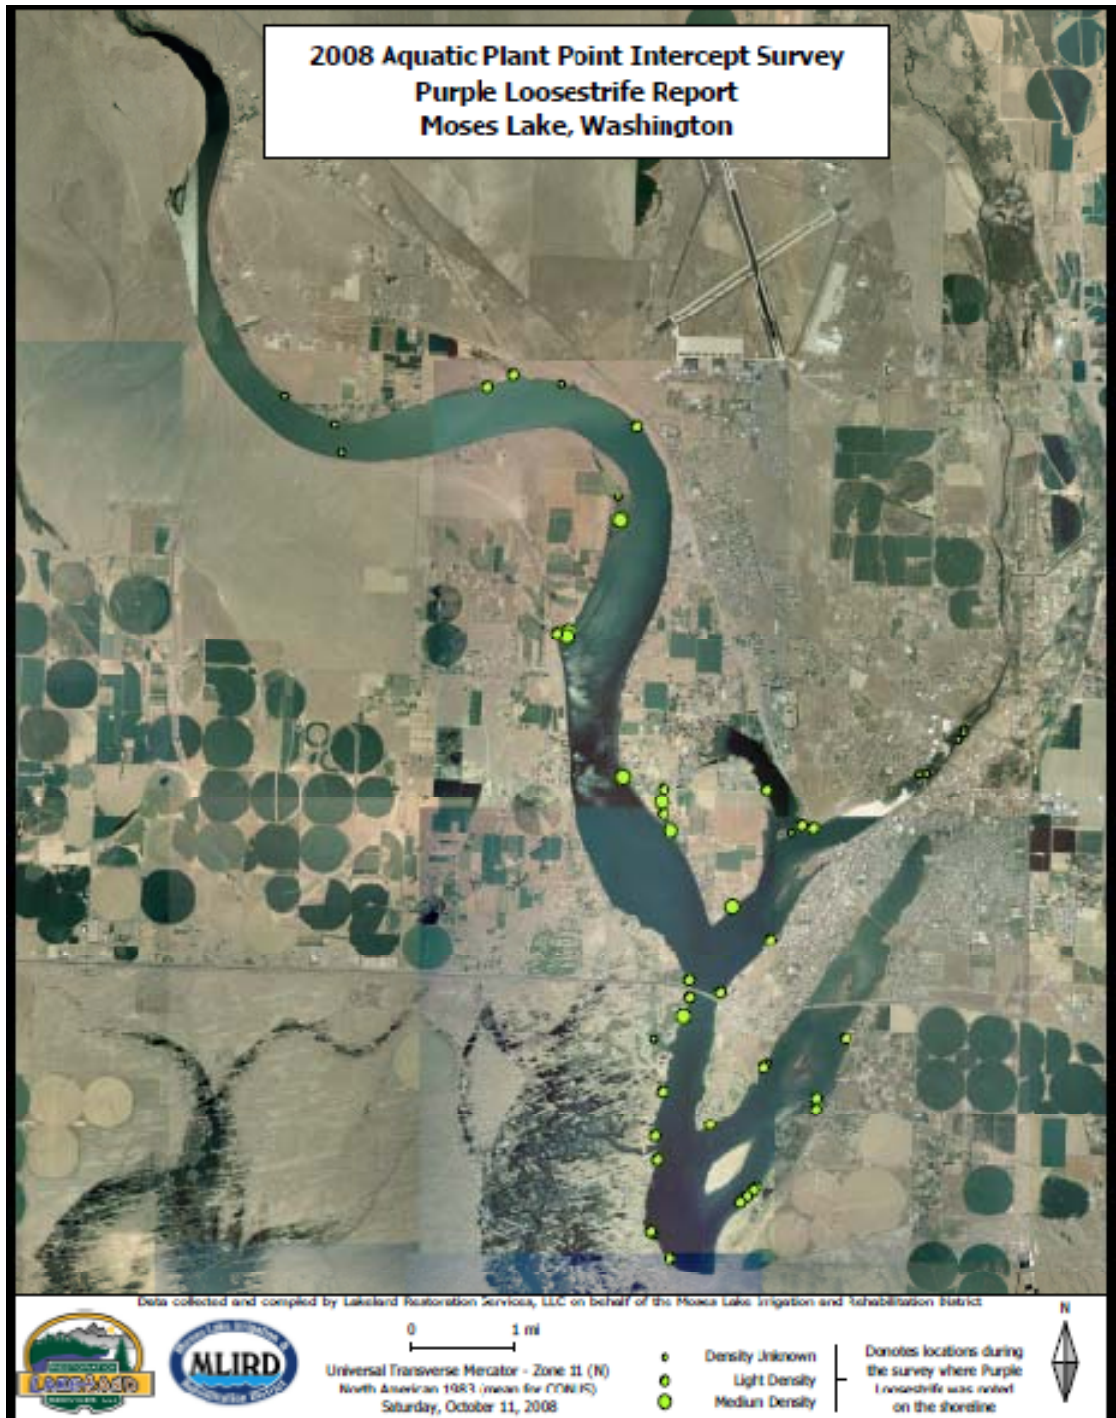
Figure 61. Purple Loosestrife (Kluttz, 2008 survey)

Purple Loosestrife was found in low density and location along the shoreline, especially in the southern portion of the waterbody, figure 61.

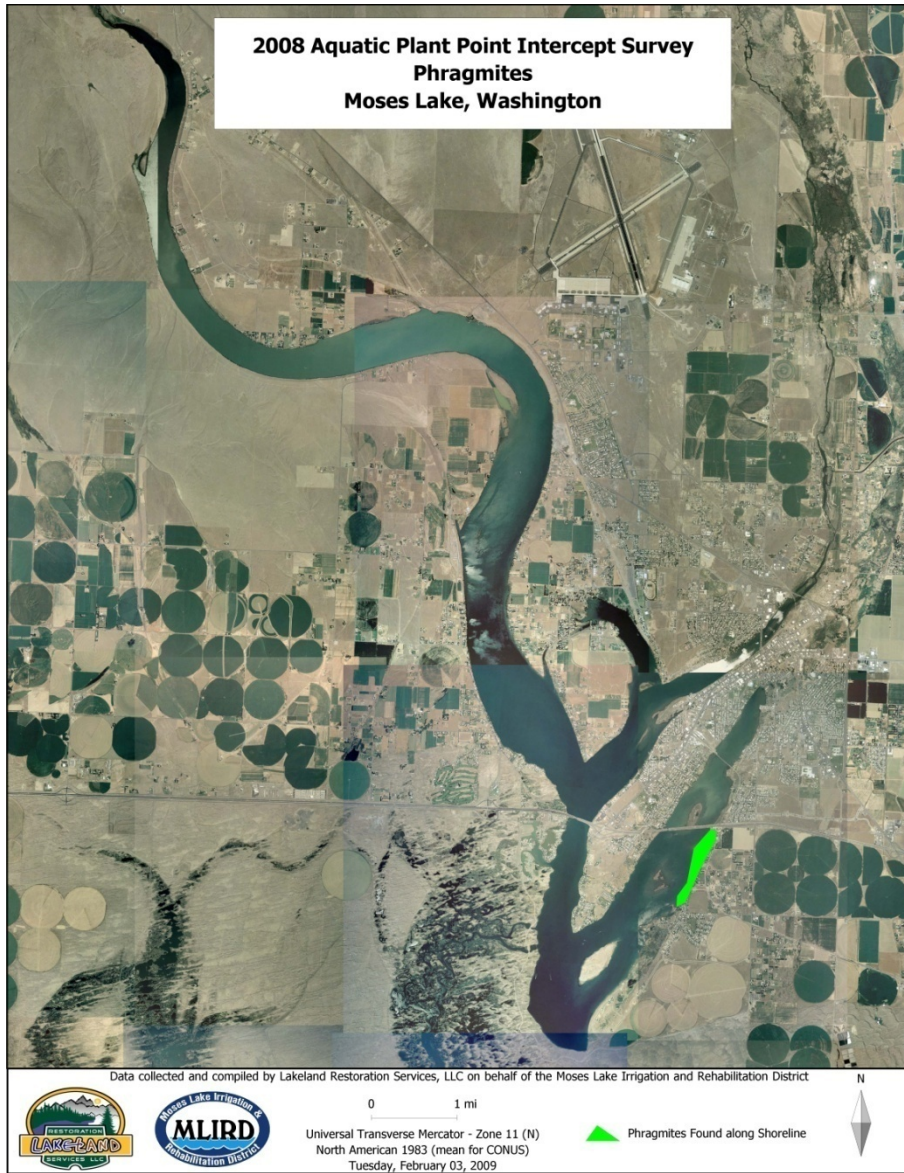
Figure 63. Fragmites (Kluttz, 2008 survey)

Phragmites was located along the shoreline of Pelican Horn, south of I-90, figure 63.

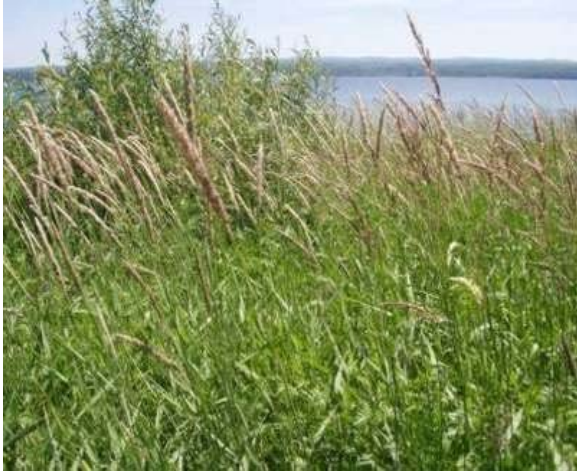
Phragmites photograph illustrating population density in wetland in Pelican Horn.

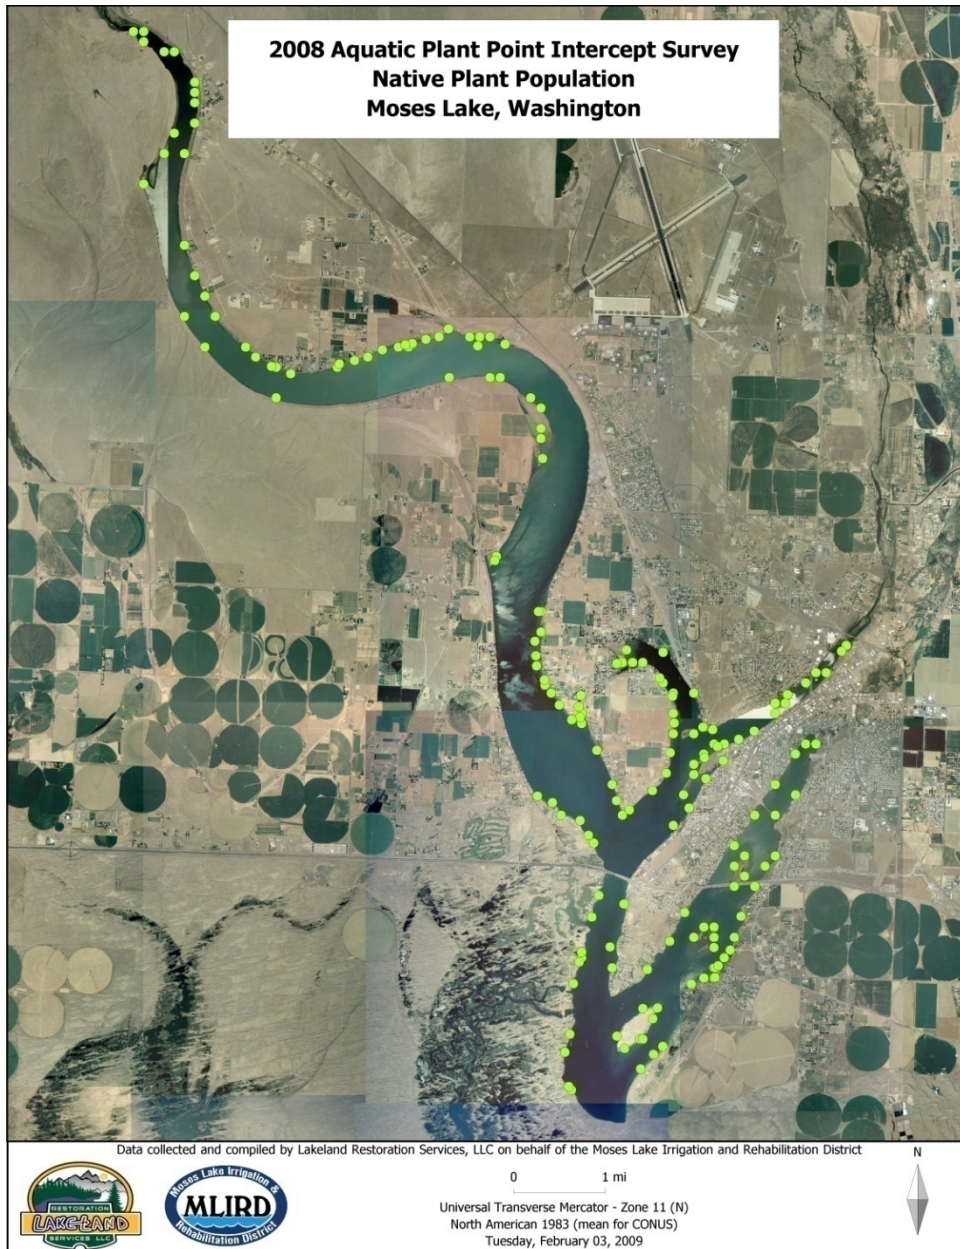
Figure 65. Native Plant Population (Kluttz, 2008 survey)

Figure 65, the native plant population illustrates where the vast number of native plants are located.

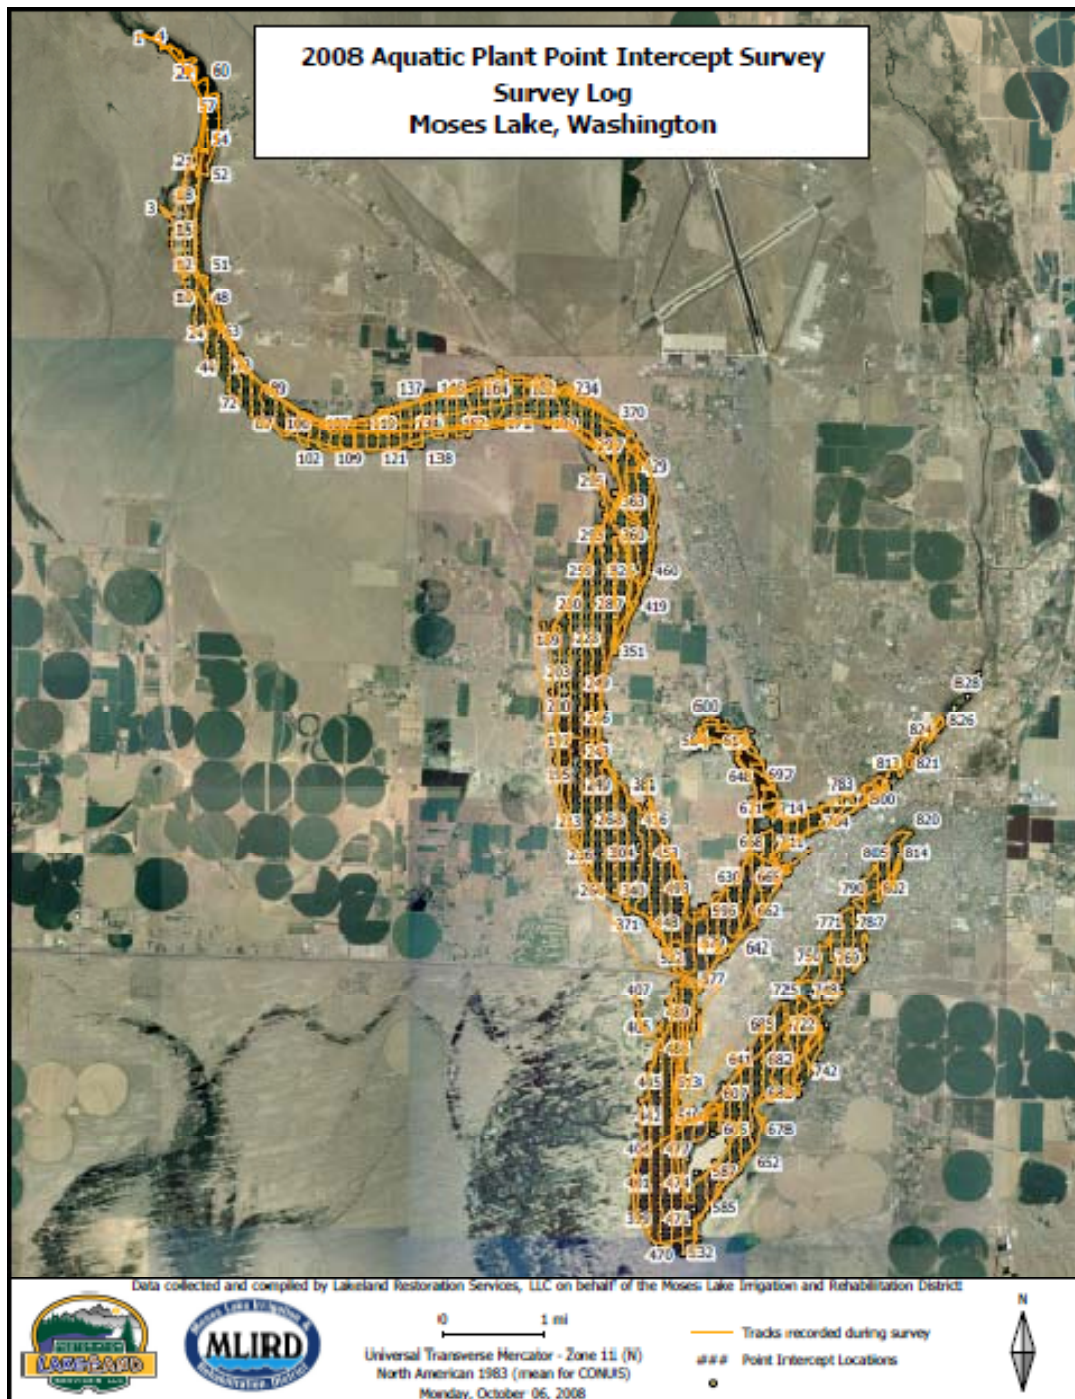
This map illustrates the extent of vegetation survey using GPS points to document the coverage of the waterbody and shorelines. All sites can be accurately revisited to determine the efficacy of treatment, figure 66.

Figure 66. GPS location documentation (Kluttz, 2008 survey)

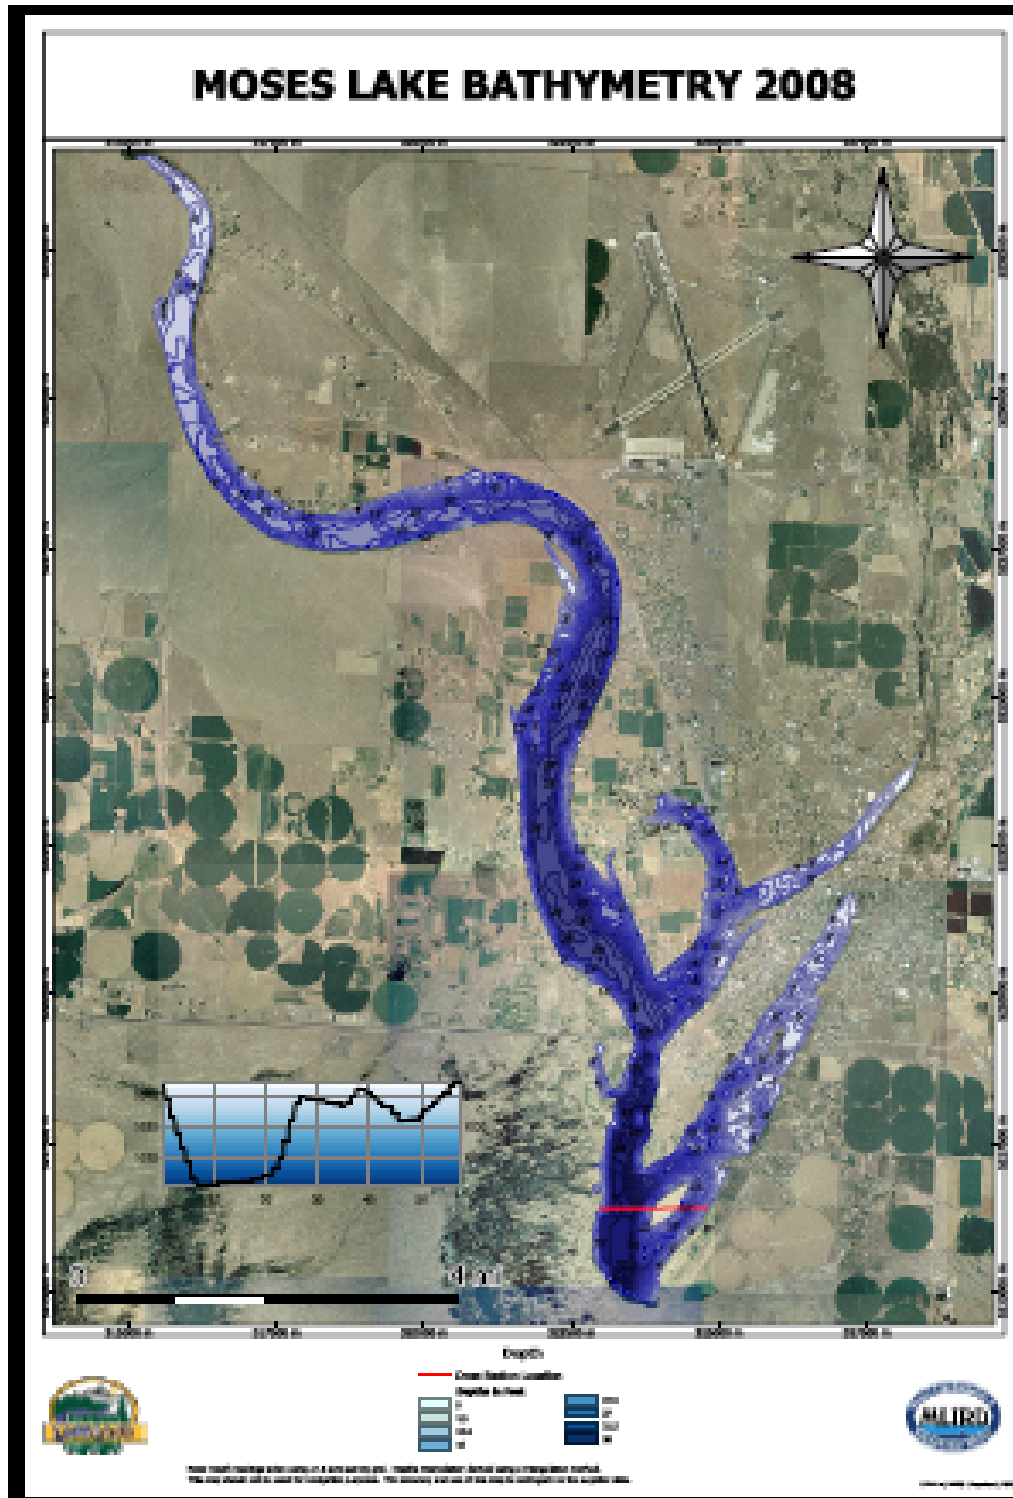
Figure 68, illustrates the bathymetry of the bottom depths of the waterbody.

Figure 68. Waterbody bottom depth contour readings (Kluttz, 2008 survey)

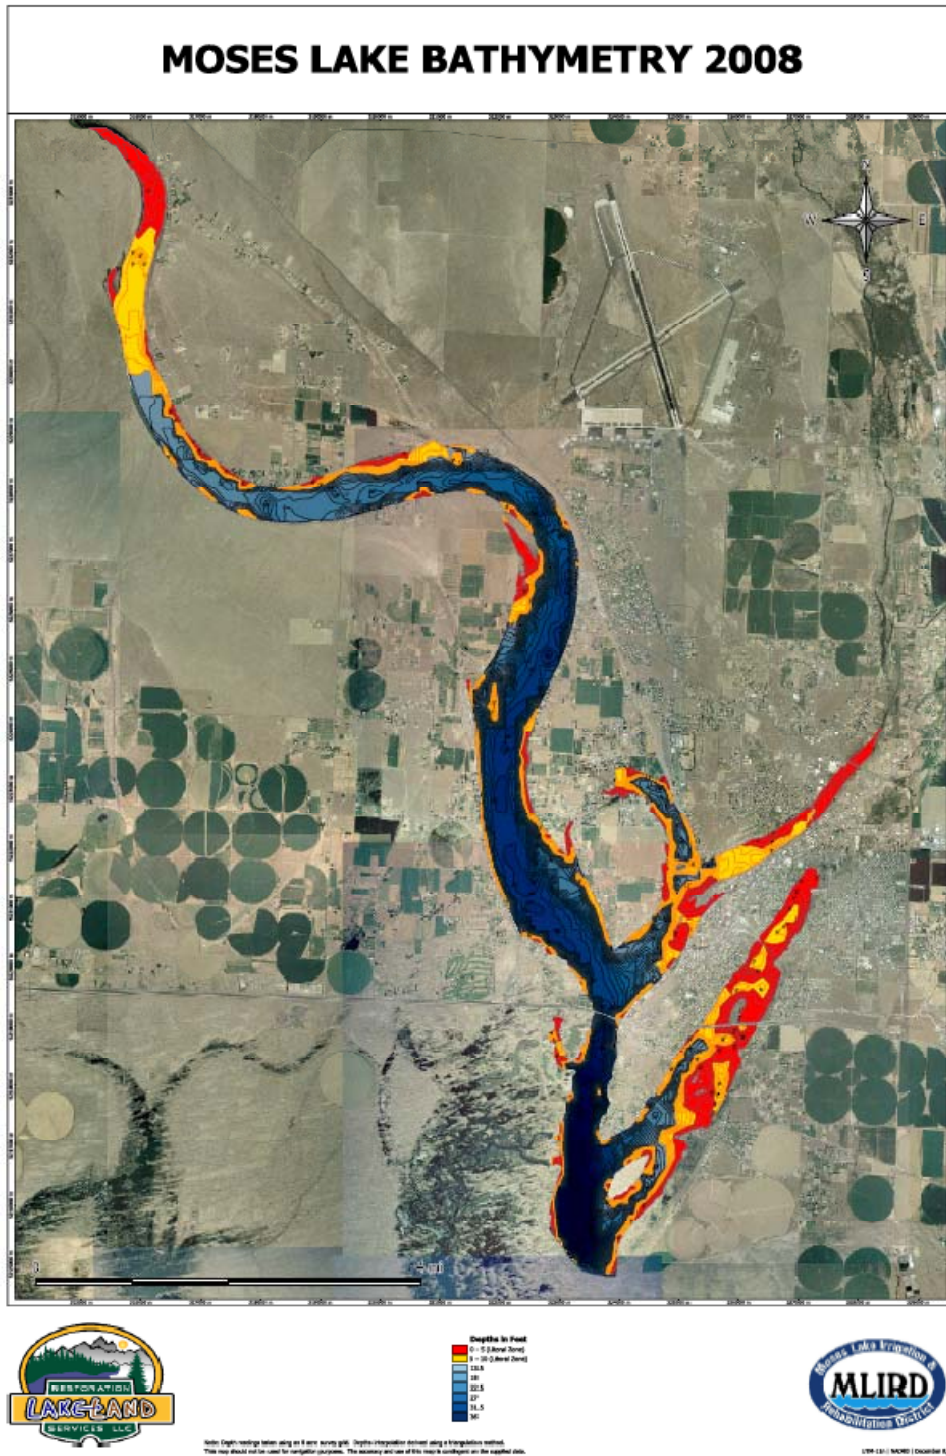
Figure 69. Graphic waterbody bottom contour in multiple legend colors.

Figure 69. Graphic bathymetric recorded waterbody bottom depths (Klutz, 2008 survey)
