## SUMMARY OF WATER QUALITY FOR MOSES LAKE SAMPLING IN 2005

# WRIA 41 LOWER CRAB CREEK 2006 – SUMMARY OF WATER SAMPLING FOR MOSES LAKE

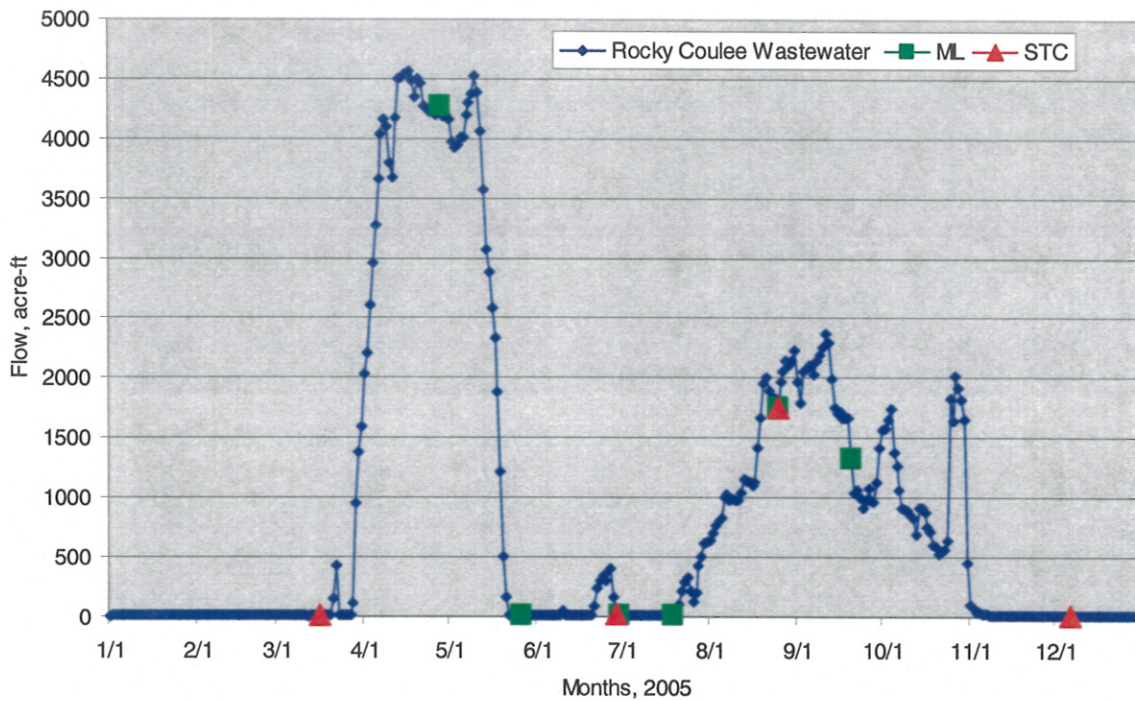
Figure 4. Dilution water added to Moses Lake in 2005 (Sampling times are indicated by arrow).

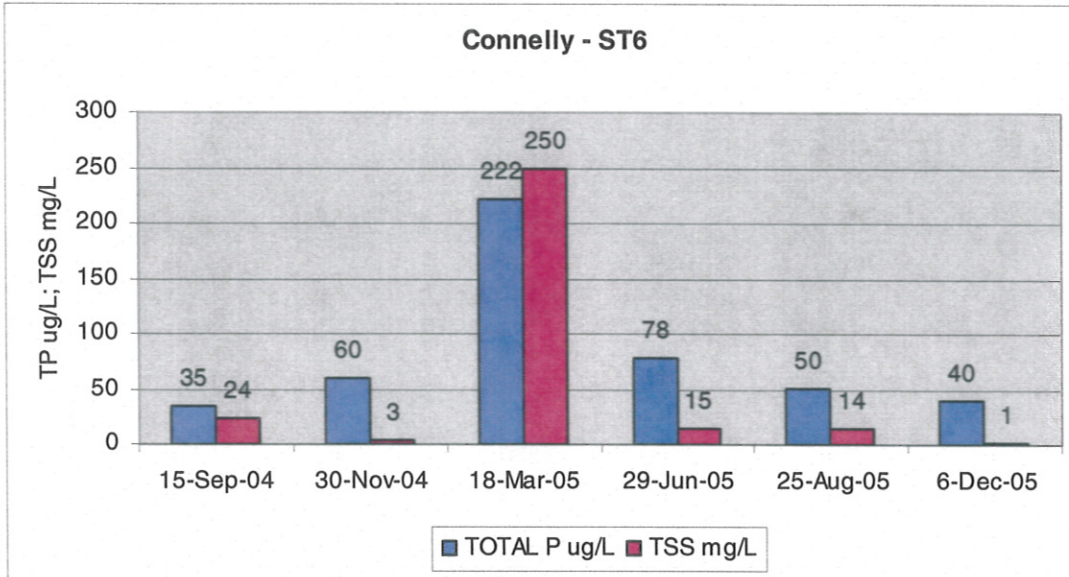
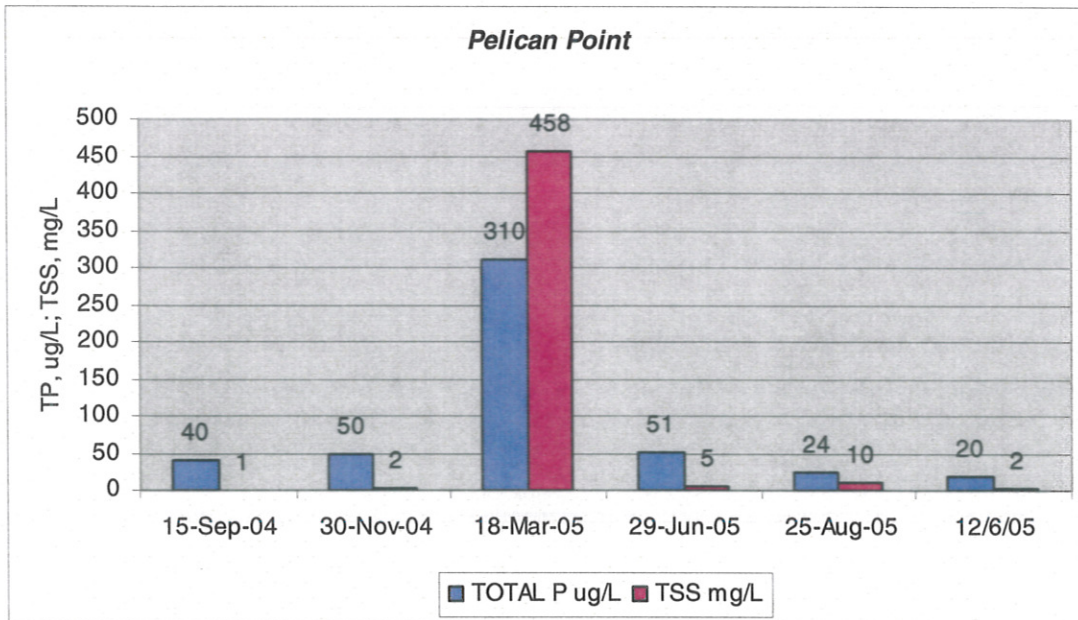
**Figure 5. Typical association of TSS and TP on in lake sample at Connelly (ST6) and Pelican Point (ST9).**

Sample collection close to shore has the most potential for elevated TP due to sampling problems and/or weather conditions. Generally the highest TP levels were measured in March when the samples also had the greatest TSS levels (Tables 19 and 21). Figure 5 shows the association for ST6 (Connelly Park) and ST9 (Pelican Point) sampling stations. March 2005 was a very windy day (D. Nelson, personal communication) which resulted in turbulence in the shallow areas of the lake. Phosphorus adsorbed to sediment results in elevated TP concentrations.

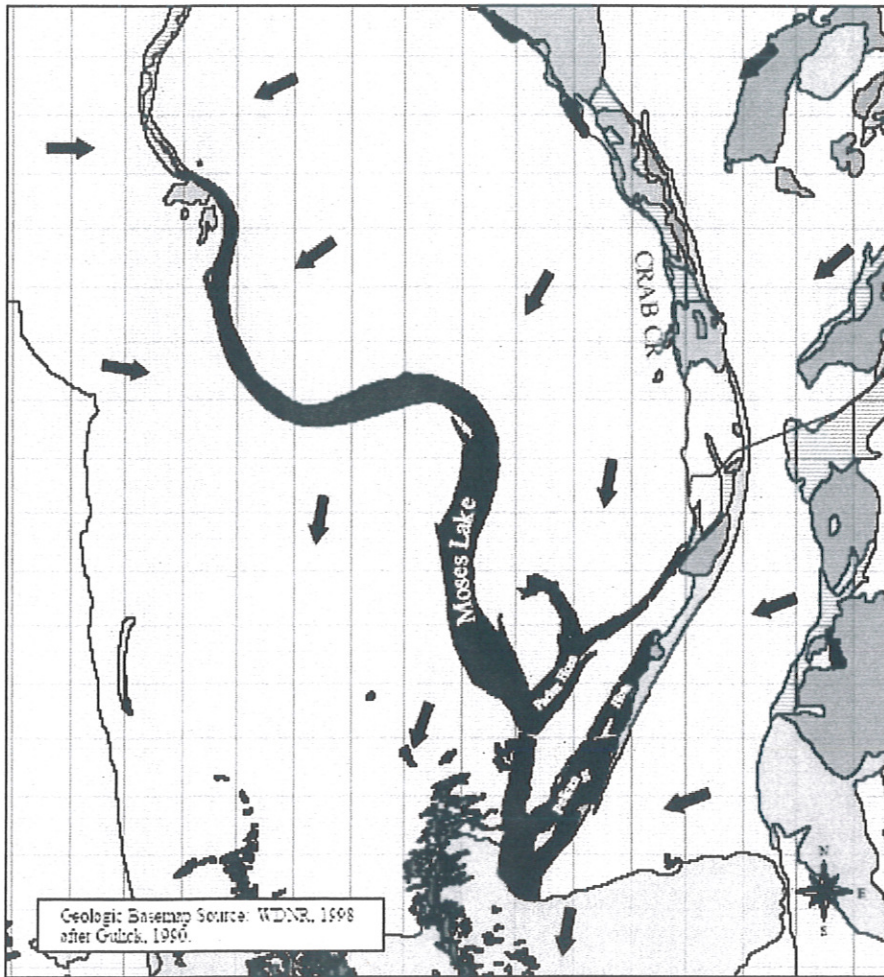
**Figure 2. Groundwater flow direction in Moses Lake basin (arrows). Tan areas around lake are Pleistocene gravel and sand flood deposits (from Pitz 2003).**

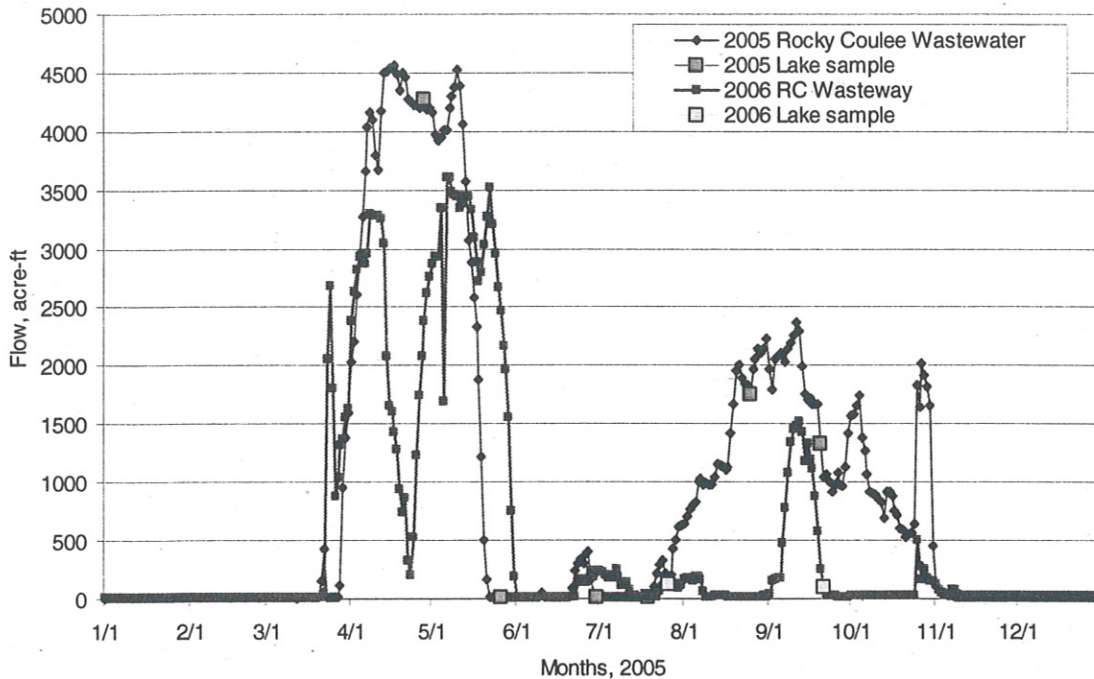
Figure 5. Comparison of Dilution flows from Rocky Coulee Wasteway in 2005 and 2006.

Total annual flow is not always a good indicator of lake quality during the summer because significantly less dilution flow is available in the summer months. Figure 5 shows that in 2006 most of the dilution flow were added before July 1; of 194,000 acre-ft added in 2006 only 87% of the annual flow was released before July 1. Therefore dilution flows in July, August, and September were very low in 2006. This was a major factor in high concentrations of TP and algae in the September lake samples.
