WRIA 41 LOWER CRAB CREEK 2006 – SUMMARY OF WATER SAMPLING FOR MOSES LAKE

**WRIA 41 LOWER CRAB CREEK
2006 – SUMMARY OF WATER SAMPLING FOR MOSES LAKE**

**Water Quality Engineering, Inc
103 Palouse Street, Suite 2
Wenatchee, Washington 98801**

March 12, 2007

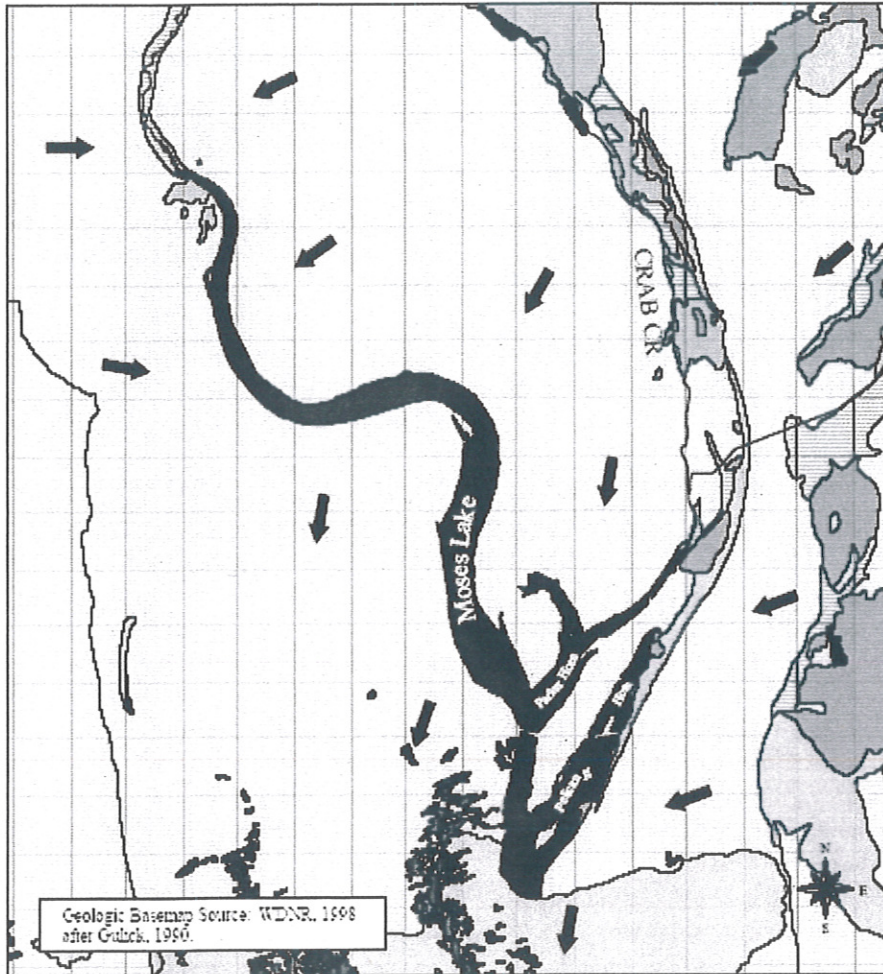
Figure 2. Groundwater flow direction in Moses Lake basin (arrows). Tan areas around lake are Pleistocene gravel and sand flood deposits (from Pitz 2003).

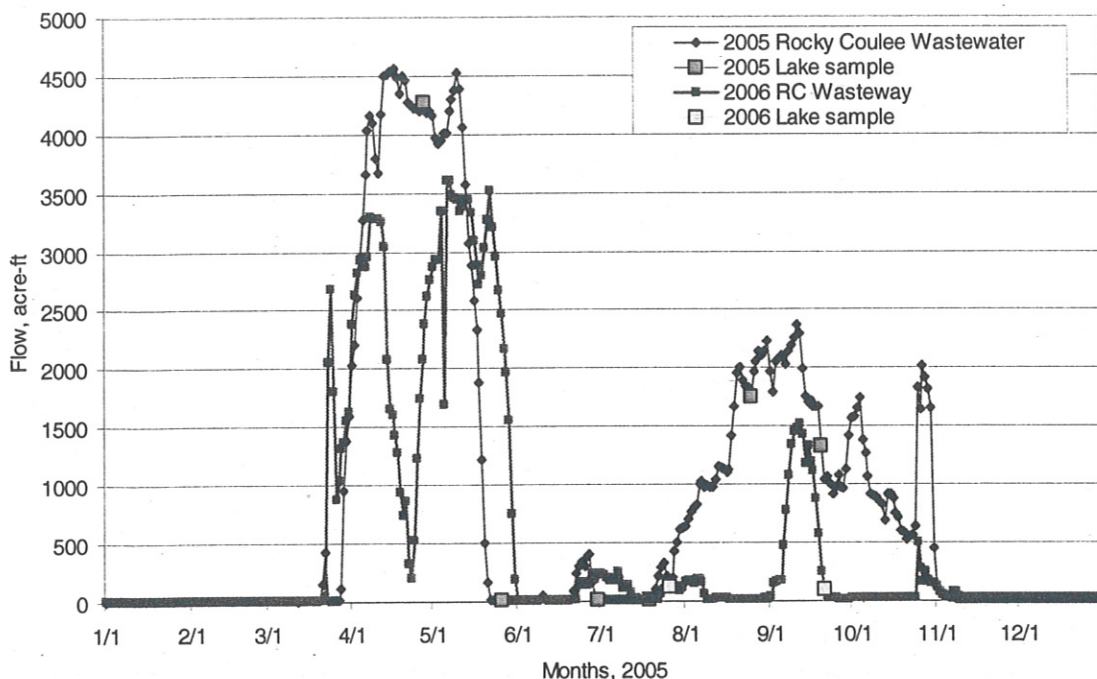
Figure 5. Comparison of Dilution flows from Rocky Coulee Wasteway in 2005 and 2006.

Total annual flow is not always a good indicator of lake quality during the summer because significantly less dilution flow is available in the summer months. Figure 5 shows that in 2006 most of the dilution flow were added before July 1; of 194,000 acre-ft added in 2006 only 87% of the annual flow was released before July 1. Therefore dilution flows in July, August, and September were very low in 2006. This was a major factor in high concentrations of TP and algae in the September lake samples.

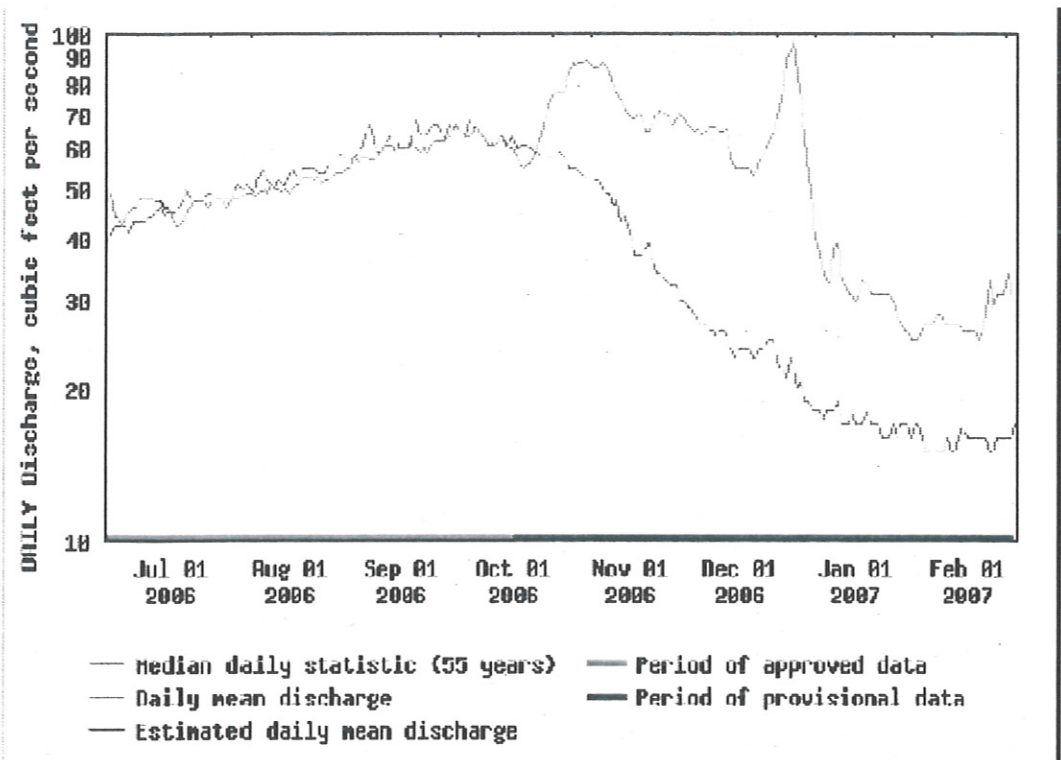
Figure 6. Crab Creek flows during USBR flow augmentation from Brooks Lake. Flow augmentation occurred from early August to December 15th 2006.

The entire supplemental feed flow from Brooks Lake was not accounted for in surface water flows at the Road 7 USGS flow gage on Crab Creek. Flows in Crab Creek peaked in mid December at about 95 cfs. This is about 75 cfs greater than expected base flows in Crab Creek for this time of year. The significant change in the hydrograph in December implies that a new flow condition for Crab Creek was developing. If supplemental flows had continued past December 15 it appears that a significant percentage, certainly greater than 50%, of the supplemental flow would have entered Moses Lake via Crab Creek.
